SCIENCE OF TSUNAMI HAZARDS

THE 1990 BOHOL EARTHQUAKE: TSUNAMI OBSERVATIONS AND EFFECTS AT BOHOL ISLAND, PHILIPPINES

The earthquake of February 8, 1990 offshore the Island of Bohol in the Central Philippines was a tsunamigenic event caused by crustal displacements along an unknown northeast-southwest trending fault. Isoleismic distribution confirmed such orientation with higher seismic intensities at the southeastern areas of Bohol Island. Subsequent field surveys, interviews with eyewitnesses and measurements of runup heights, support that significant tsunami inundation occurred along the southeastern coast of the island. Based on this investigation and review of historical data, we conclude that the source region of the 1990 tsunami was along an unknown offshore submarine structure.

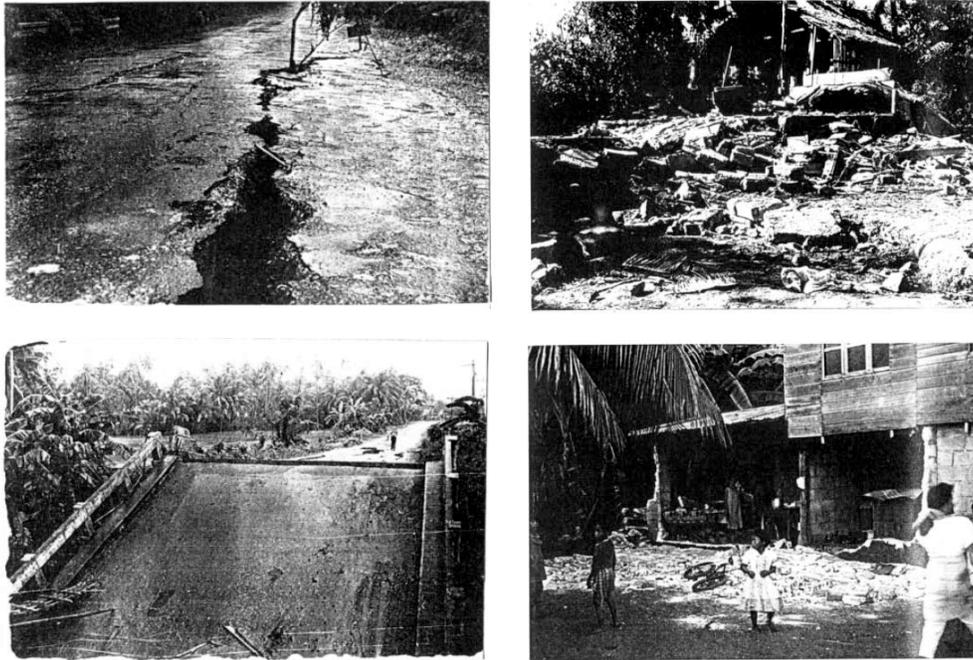
Based on eyewitness interviews, it was determined that the quake's shaking lasted for about 3-7 seconds. Along the southeastern shores of the island, strong ground motions, widespread ground fissuring, landslides, subsidence and mud fountaining were responsible for most of the significant damage to the infrastructure of municipalities. Reportedly, a bridge collapsed and roads were closed by rockfalls. Figure 4a shows some of the damage.

Figure 4a: Photos adapted from Umbal et al. (1990) showing the damages at Guindulman (A), fault rupture near Anas (B), the collapsed bridge at Alijauan bridge at Jagna (C) and collapsed house in Candabang, Anda (D).

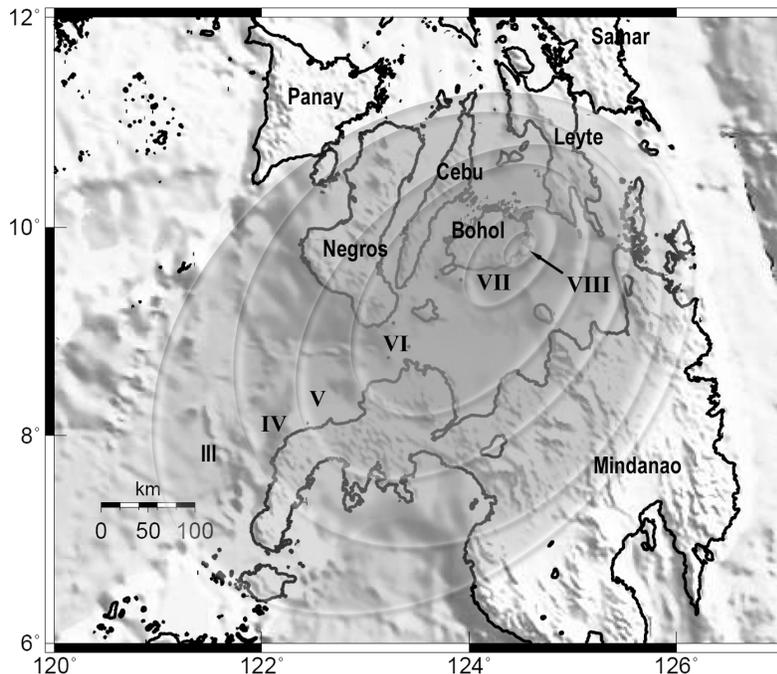
Remnants or repairs of century-old churches indicated the extent of severe ground shaking in numerous towns. Based on observations of ground shaking and the associated environmental damage, an isoseismal map was prepared (Figure 4b). High intensities with NE-SW orientation were concentrated along the southeastern part of the island. Mapped ground ruptures (Umbal et al., 1990) were located about 7 km south of the EBF (Figure 2) and west of the highest observed intensities.

Figure 4b: The earthquake intensity distribution of the 1990 Bohol earthquake based in this study and Umbal, et. al. (1990). Note the northeast-southwest elongation of the isoseismals.

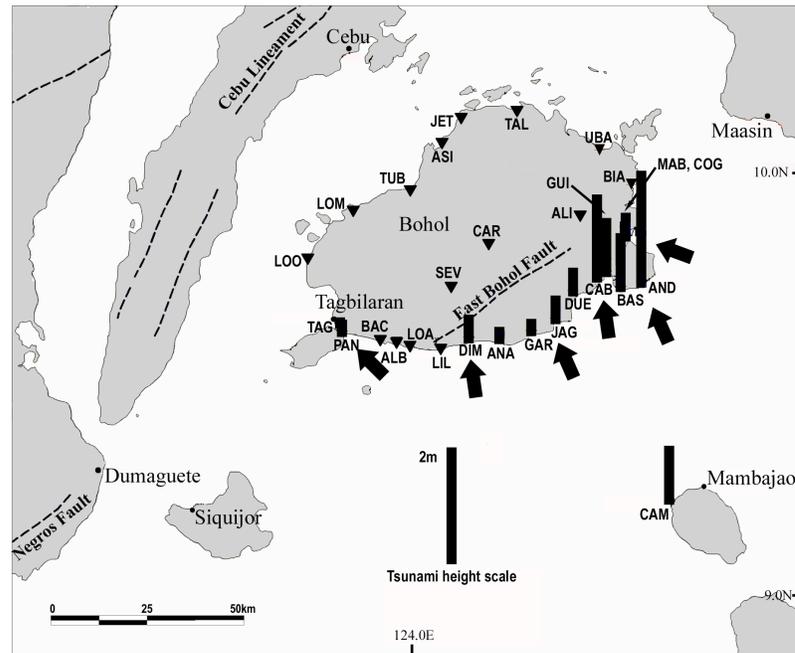
Evidently, the 1990 earthquake generated small to moderate tsunami waves which affected the SE portion of Bohol (Figure 5). The maximum runup height of 2.11m was measured at AND that extends to MAB in the northeast and to TAG in the southwest. Between DIM and PAN, there were only reports of the sea level lowering, but no unusual increase in wave height or tsunami inundation. The reported tsunami at PAN and TAG could probably be due to possible island trapping effect (Yeh et al., 1994; As-Salek, 1998). It is noted that most notable tsunami runup heights were concentrated along the southeastern portion of Bohol Island - including a report from Camiguin island (CAM) of

1.2m based on PHIVOLCS official logs and records at the Hibok-hibok Volcano Observatory. The measured tsunami runup heights had an average height of 1m which was not sufficient enough to cause much destruction. The horizontal tsunami inundation was variable but generally extended to a few tens of meters from the shoreline. Fortunately, the local low tide at the time was low. If the tsunami had occurred at high tide inundation would have been at least 1m higher than what was observed.

Figure 5: *Tsunami heights measured for the Bohol 1990 quake. Broad arrows indicate the observed direction of the incoming tsunami waves.*

Based on eyewitness accounts, the main direction of the tsunami approach at AND and BAS was toward the north (N), toward NNW at DIM JAG and toward NW at PAN and COG. The direction of propagation indicated that the tsunami had its origin in an area southeast of Bohol. Eyewitnesses reported that the first wave throughout the southern shorelines of Bohol was associated with a depression in sea level. Accordingly, the southeastern shorelines of Bohol experienced a regional sea withdrawal of about 10-200m several minutes after the ground shaking stopped. In areas like BAC, ALB, LOA and LIL, some of the people indicated that the lowering in sea level occurred several minutes after the ground shaking, while others did not note an unusual change. At DIM and ANA, there was a rapid withdrawal of the sea, resembling low-tide, that trapped fish in the reef zone. The sea returned with foamy front and there were at least seven such oscillations. At GAR, however, there was only one wave observed which was 0.32m higher than the normal level. However, an eyewitness in JAG, remembered the trapped fish, cracks on the ground and sandboils when the water retreated three times about 150m away from the shoreline.
