# **FIELD SURVEY OF THE DECEMBER 26, 2004 TSUNAMI AT KANYAKUMARI, INDIA**

**Arun Bapat,  
Seismological Consultant, Pune (India),  
Tad Murty,  
Department of Civil Engineering, University of Ottawa, Ottawa, Canada.**

## **Abstract**

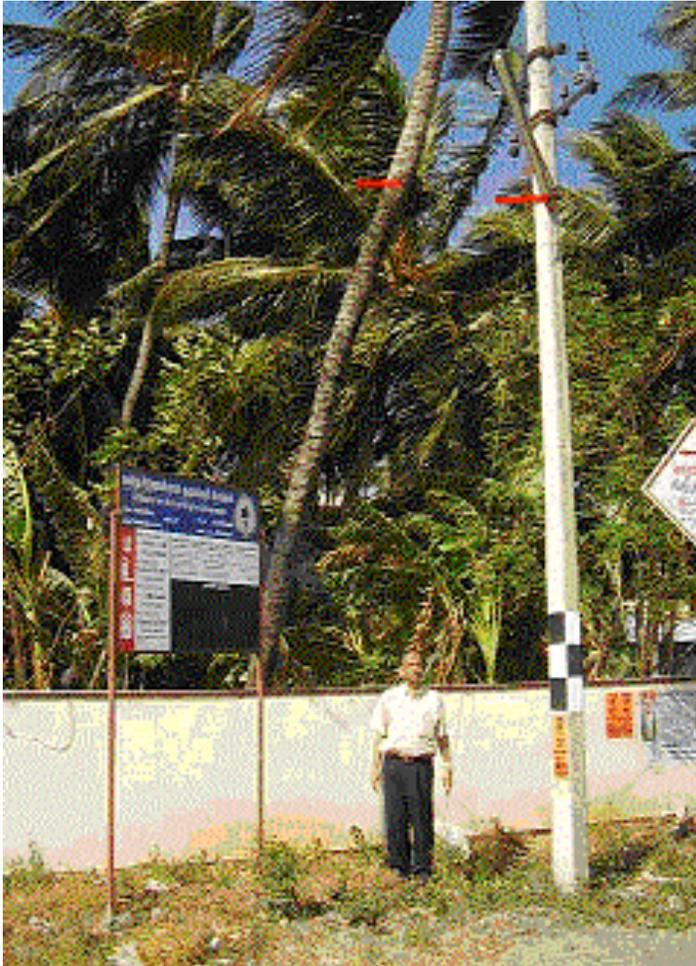
- (e) During the survey, the team observed a young coconut tree with color markings on the trunk that clearly indicates the tsunami's height (Photo 1).

On the western side of the bridge, inside a house compound, a coconut tree had discoloration (Photo 1) up to a height of 6 m. This mark could be correlated to the tsunami height at that location (plus ground height of about 3 m).

*Photo 1. Shows the tsunami mark on the coconut tree and metallic part on the electric lamppost, which have been corroded.*

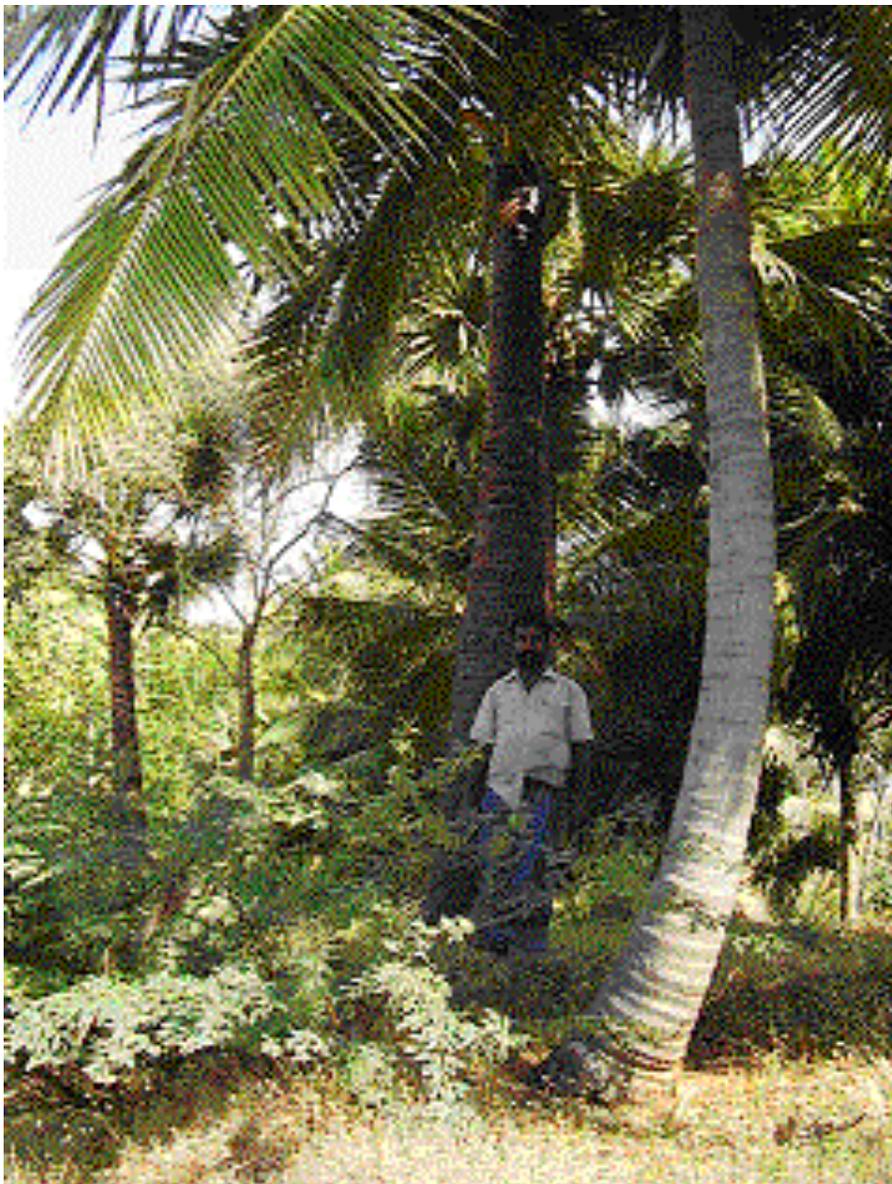
- (f) Mrs. Muttama Palmani, a 50-year old lady, was struck by the tsunami and got stuck up on a tree. Her nephew Selvaraj was also washed away and got stuck up on another tree (Photos 2 and 3). These observations were useful in determining the height of the tsunami at this location.

*Photo 3. Selvaraj was stuck up at the tree where he is standing. The distance between this tree and the tree on which Muttama was hanging is about 15 m.*

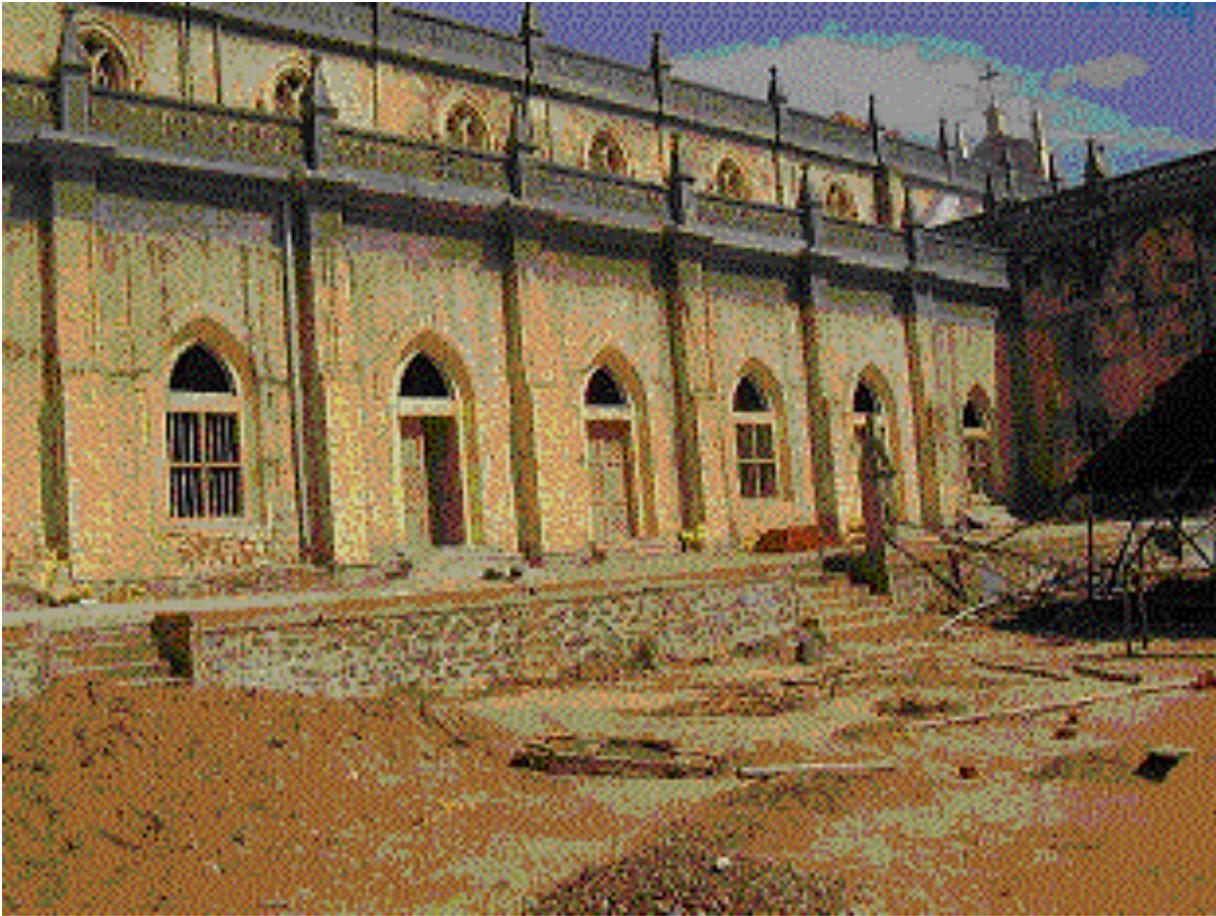
- (g) A church (shown in Photo 4) has been subsequently repaired. However, the height reached by the tsunami at that location was obvious.
- (h) In addition to the placing Gabions, suitable pre-tsunami warning mechanism may be worked out. In addition to the announcements on radio and television, it would be most effective if the tsunami warning were sent by SMS. At present it is possible to send SMS by one operation to about 3000 to 5000 Cell phone users. Suitable mechanism may be worked out with cell telephone companies.

- (g) In the Manakkudi village enroot to the beach, a Church located at about 2m above sea level has undergone repair about 6 m from ground through out the sea side wall (Photo 4).

*Photo 4. The repairs on first floor indicate damage during tsunami and the level of Tsunami height.*

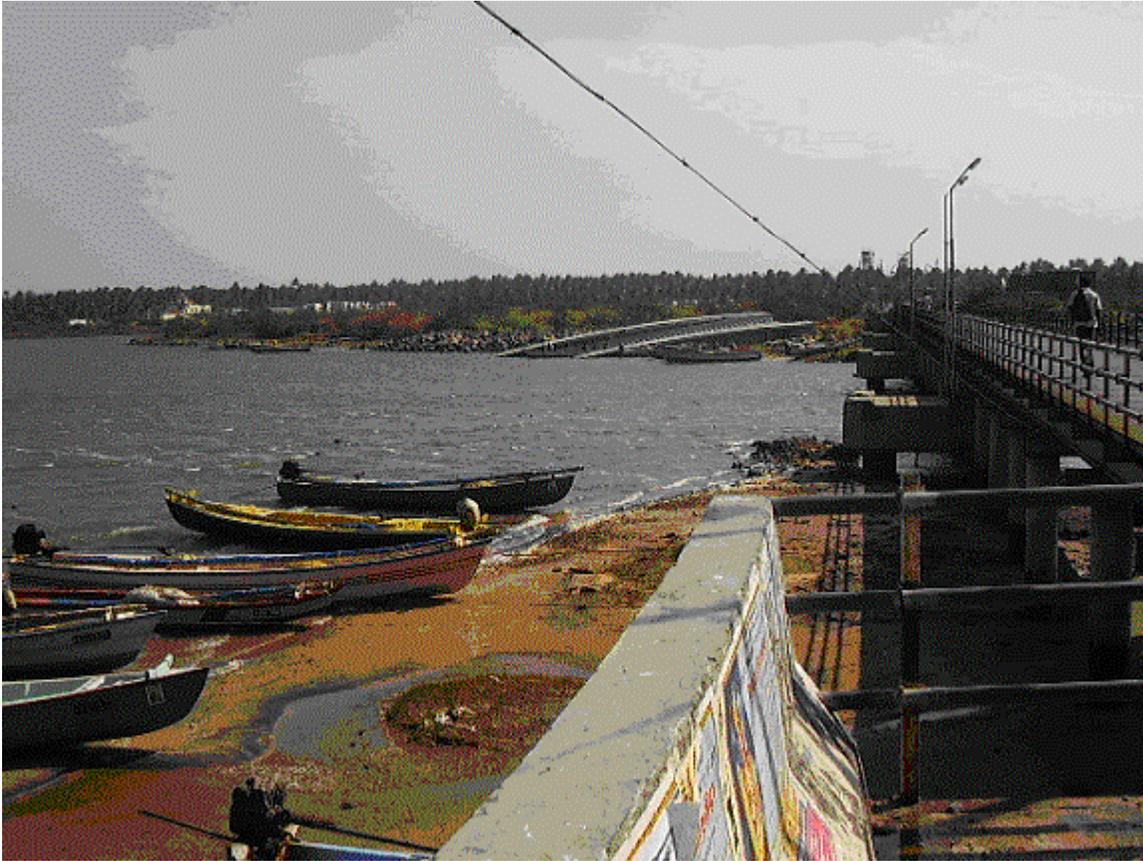
- (a) At around midnight on 25<sup>th</sup> December 2004, it was reported by the security guard that a powerful wave struck the coast and that small boats were damaged. (See Photo No.6 of damaged boat).
- (b) His son informed him on the telephone about the rough sea conditions at Chennai. At about 0900 hrs he went out and saw that the seawater was highly muddier than normal and that the wave heights were higher than usual.
- (c) He immediately stopped the ferry, which was about to start. The shipping corporation has two ferryboats.
- (d) At 0945 hrs the first tsunami wave arrived from east. This was followed by several more waves of increasing heights. The most powerful wave of 8.0 m height occurred at 1110 hrs.
- (e) Both ferryboats were lifted up by the tsunami waves and were placed on the jetty.

*Photo 6. Damaged bridge is seen at rear center. Bridge on right is the new bridge.*
