**IMPACT ANALYSIS OF THE 2018 TSUNAMI ON SULAWESI ISLAND USING  
SATELLITE IMAGERY**

**ABSTRACT**

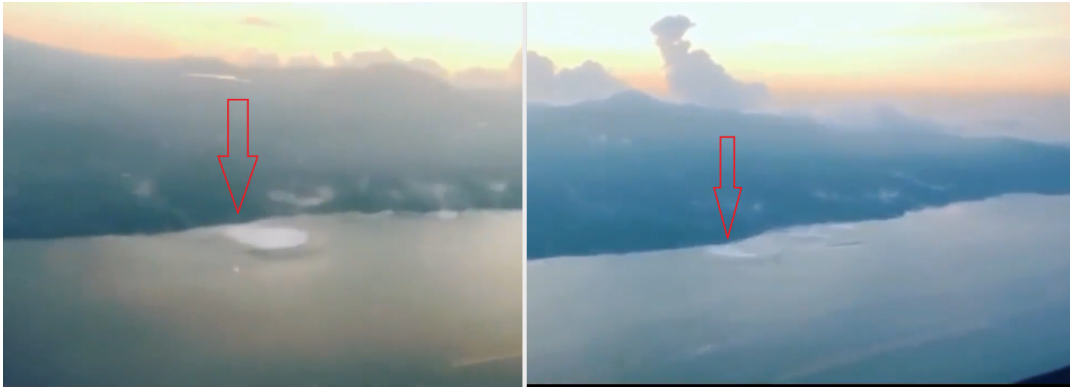
Fig. 2 Photo of landslide in Benteng - left and Tamunggu - right

Tremors during the earthquake caused several large landslides in the bay, which caused a strong tsunami [Zaytsev et al, 2019b; Sassa S. and Takagawa, 2019; Nakata et al, 2020]. The descent of two such landslides in the areas of Benteng (Buenteng) and Tamunggu (Tamungu) was captured (Figure 2) by the pilot Icoze Mafella (<https://www.youtube.com/watch?v=WkrBP9bnTcw>) of Batik Air, who by a fluke took off a minute before the earthquake. Note that the airport was partially destroyed by an earthquake and this affected the speed of restoration work.

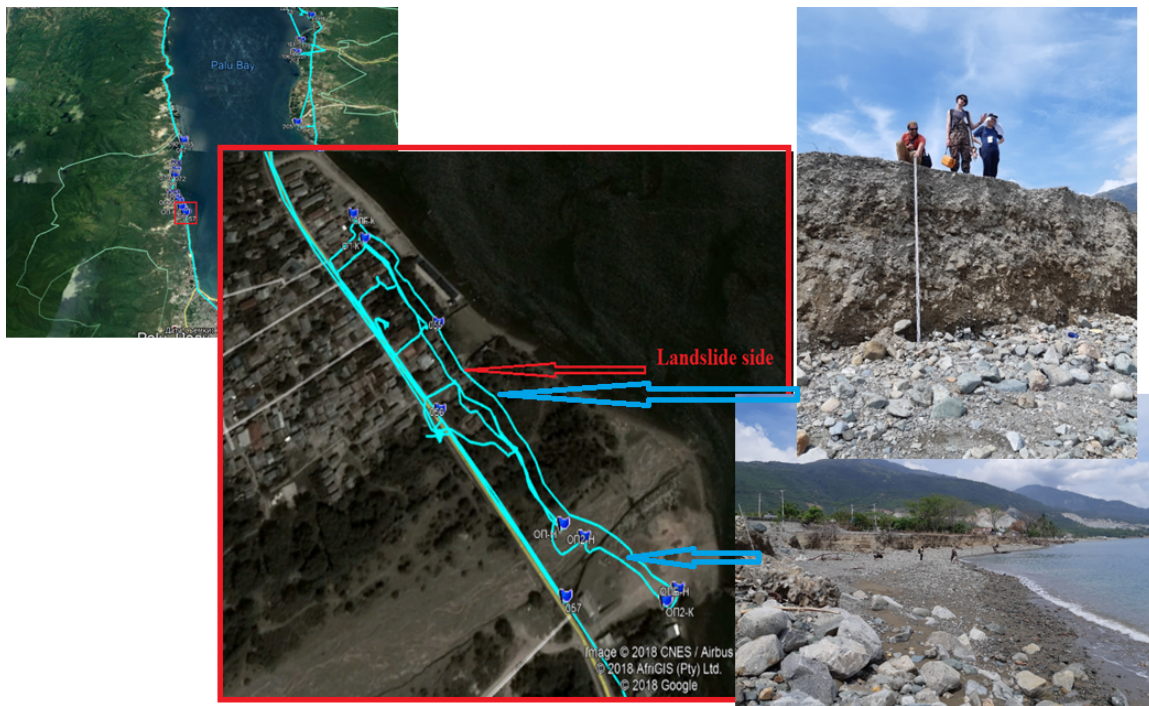
Fig 4. Benteng region

Satellite images and of the tsunami wave heights measurements in the area of the Benteng village showed that a large part of the coast, more than 500 m length and a maximum width of about 120 m, move to sea (Figure 4). Note that a significant part of the landslide was probably under water and therefore the volume of the landslide can be estimated after additional sonar hydroacoustic studies. The height of the tsunami waves at this point reached of 9 m. Tsunamis of landslide origin are usually local in nature and lead to maximum heights in the area of the landslide. Note that this landslide was located in the area of the river bed, like almost all the others that were discovered during the expedition. The layer of bottom precipitation in the river accumulates for a long time and then is driven by external influence.

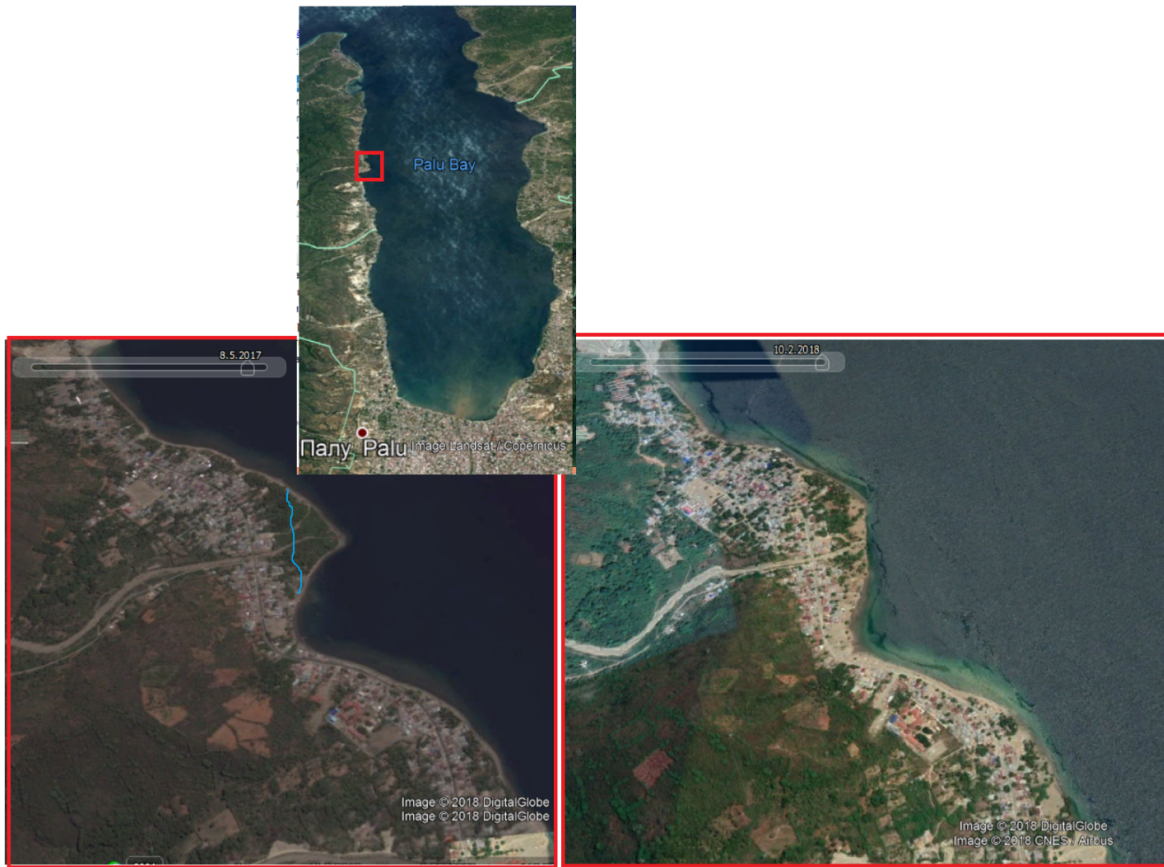
Satellite images of the Lolli Pesua village area, taken before and after the tsunami, showed that a large part of the coast more than 500 m length and with a maximum width of about 200 move to sea (Figure 5). The height of the tsunami waves at this point reached a height of 4.9 m.

Fig 5. Loli-Pesua area, left satellite picture before earthquake, right after earthquake and tsunami

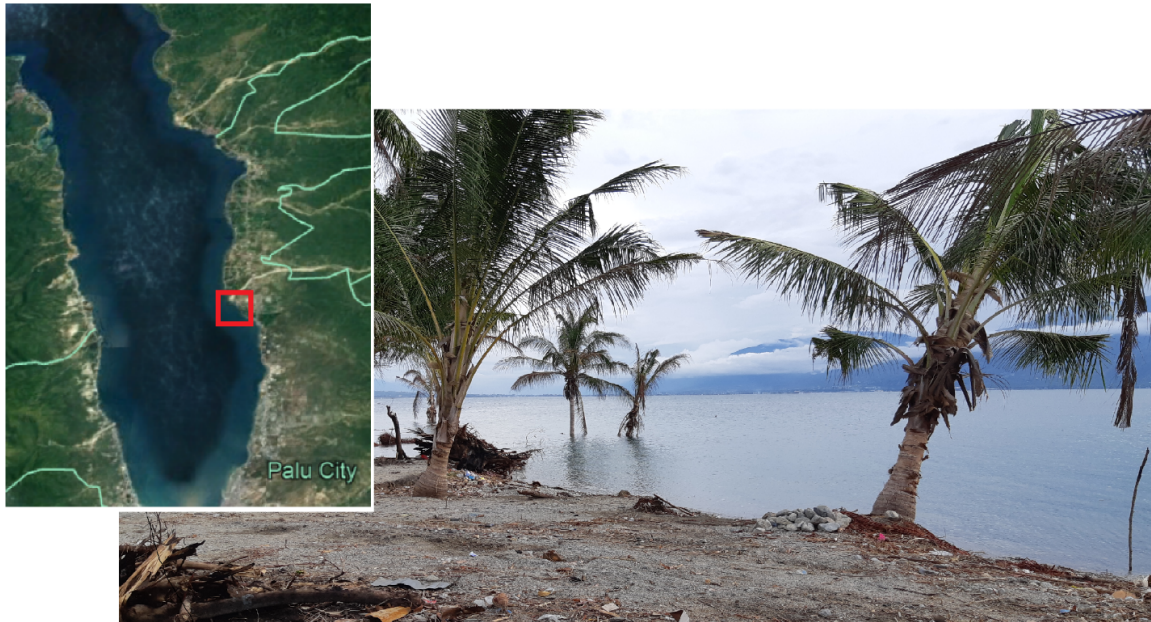
Fig. 7. Bamba region

Witnesses reported that the first wave arrived 2-3 minutes after the earthquake. The height of the splashes reached a height of 4.5 m, and the height of the tsunami wave run-up was 2.9 m. The height of the water flow near the structure was 1 m. In this area, part of the coast was submerged by 2 m, which can be seen in the satellite image (Figure 7), and this is practically observed on the entire eastern coast of Palu Bay.

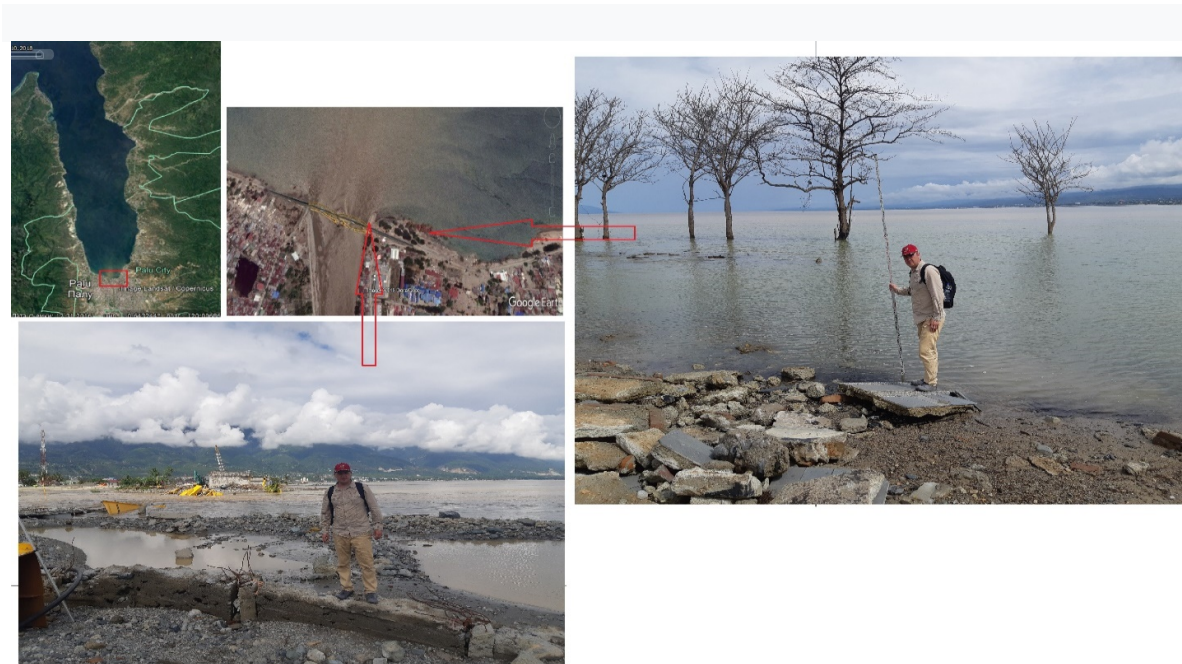
Fig. 8. Palu region

A survey of tsunami traces was carried out in the affected part of the city of Palu. Located in the center of Palu Bay, with a population of about 350,000, this town has an airport that has been damaged. The city was badly damaged after the earthquake and tsunami (Figure 8). A large bridge was destroyed and a park with buildings along the coastline was destroyed, which is especially clearly visible on satellite images (Figure 9). The height of the tsunami waves here reached a height of 11 m. After the earthquake, part of the coastal zone plunged into the sea to a depth of 2 m. Satellite images of the affected part of the city of Palu before and after this catastrophic event (Figure 9) show that most of the coastal zone is destroyed and soil erosion after the tsunami is observed in a significant area.
