**TSUNAMI DESTRUCTION IN JAPAN CANNOT BE PREVENTED WITH USE OF EXISTING SEAWALLS – Case Study: The Great Tsunami of 11 March 2011****Yuuji Tauchi**

A megathrust magnitude 9.0–9.1 (M_w), undersea earthquake on 11 March 2011 off Japan's Tohoku region on the Pacific coast, generated massive tsunami waves. Extremely high waves and the resultant debris flow overtopped and destroyed the existing seawalls which offered little or no protection, thus resulting in thousands of deaths and causing extensive destruction of coastal facilities, including the Fukushima Daiichi nuclear plant. The tsunami destroyed easily the tidal gates on the roads connecting the port to the town, and since there was no seawall protection on the tsunami's path on rivers, there was also extensive inland damage upstream, as the waves striking over river banks reverted river flows, thus causing the water to rise and form even higher waves with greater inland inundation. Even weak tsunamis striking a river outlet on a coast can generate a high-volume river water flow reversal and potentially cause substantial damage upstream. The present government tsunami countermeasures in Japan for such river areas are unable to p

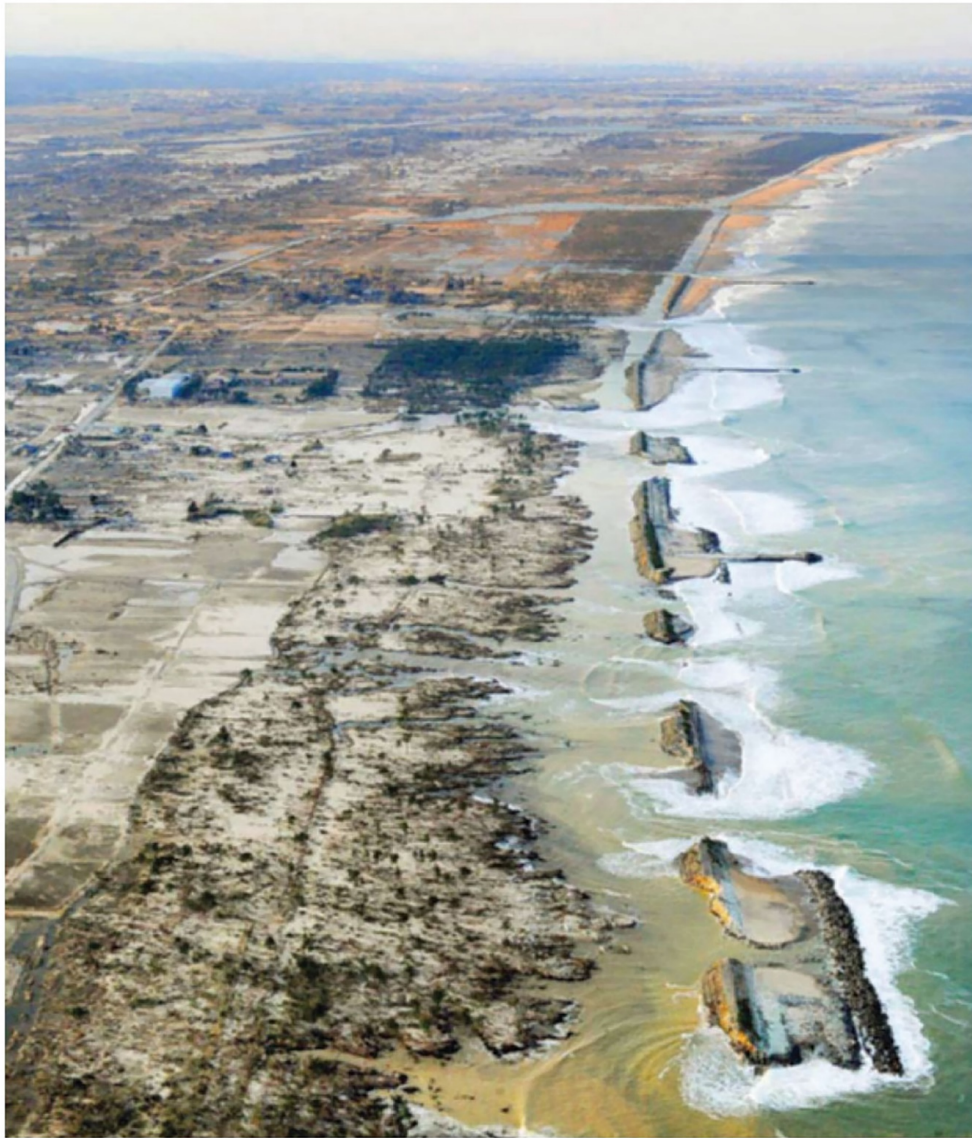
The 2011 tsunami caused immense damage to seawalls and other protective structures along the coastal Tohoku region. Specifically, about 190 km of the coast's 300-km seawall was completely or partially destroyed. Also, the waves of the tsunami resulted in the inland deposition of sediments of up to 50 centimeters in thickness. The force of the tsunami wave impact and the flow of the debris contributed in the whole or to the partial destruction of the seawalls which had been designed to only withstand seawater hydraulic pressures. As shown in Fig. 1, a seawall on the coast of Yamamoto Town in the Miyagi Prefecture and the base of the levee were shredded by the force of the waves of the 2011 tsunami (Mano et al. 2013).

Fig. 1. Seawall destroyed by a tsunami (Mano et al. 2013)

Subsequent studies examined the failure mechanism of coastal levees on the Sendai Bay Coast hit by this 2011 gigantic tsunami, and determined that almost eighty percent of these intended to protect the land from storm surges were broken in various degrees of damage by the tsunami (Mano et al. 2013). However, following this disaster, both national and local governments decided to rebuild these levees to be durable to withstand even the force of mega tsunamis.

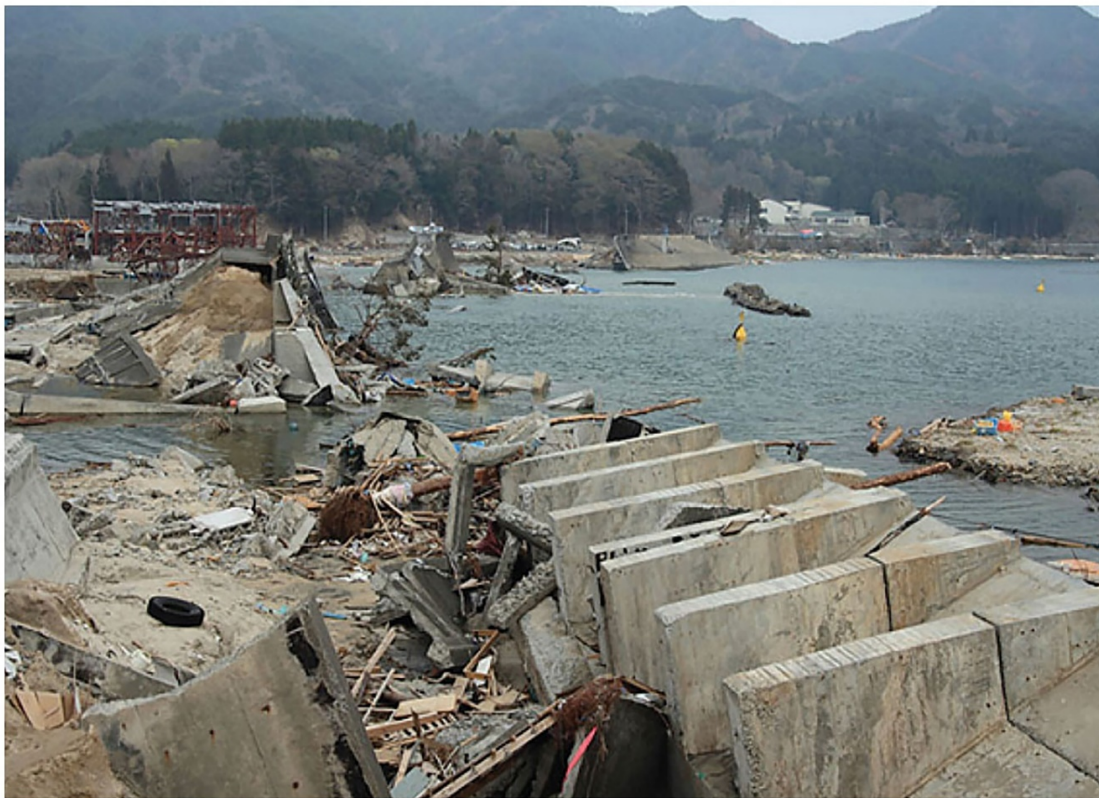
The height of the levee was high on the beach, and was designed to only withstand seawater pressure and to offer protection to storm generated surges, but of not of sufficient strength to protect from changes in the seabed topography due to tsunami flooding and subsidence of its foundation – in spite of the embankment’s reinforcement with concrete (Fig. 2). In brief, tsunami waves containing large amounts of sludge and sediments are much more destructive. For example, the great Meiwa Tsunami of 1771 carried a 1000-ton rock to a point 35 m above sea level and 100 m from the coast on Ishigaki Island (Travel JP, Okinawa travel guide). Since this tsunami had a run-up height of 85 m, seawalls would offer no protection from its damaging effects. Additionally, ports have shipping routes that lead to the open sea. Therefore tsunami wave can impact ports through these shipping route openings. Figure 2 depicts a port’s seawall, completely destroyed by a tsunami.

Fig. 2. Seawall of a harbor in Yamada completely destroyed by a tsunami.

The sturdy doors that blocked the road between the port and town were also easily destroyed. Simply, increasing a coastal seawall height will not mitigate sufficiently the
