SCIENCE OF TSUNAMI HAZARDS

The International Journal of The Tsunami Society
Volume 29 Number 1 Published Electronically 2010

DESIGN LOAD EVALUATION FOR TSUNAMI SHELTERS BASED ON DAMAGE OBSERVATIONS AFTER INDIAN OCEAN TSUNAMI DISASTER DUE TO THE 2004 SUMATRA EARTHQUAKE 11

**DESIGN LOAD EVALUATION FOR TSUNAMI SHELTERS BASED ON DAMAGE
OBSERVATIONS AFTER INDIAN OCEAN TSUNAMI DISASTER DUE TO THE 2004
SUMATRA EARTHQUAKE**

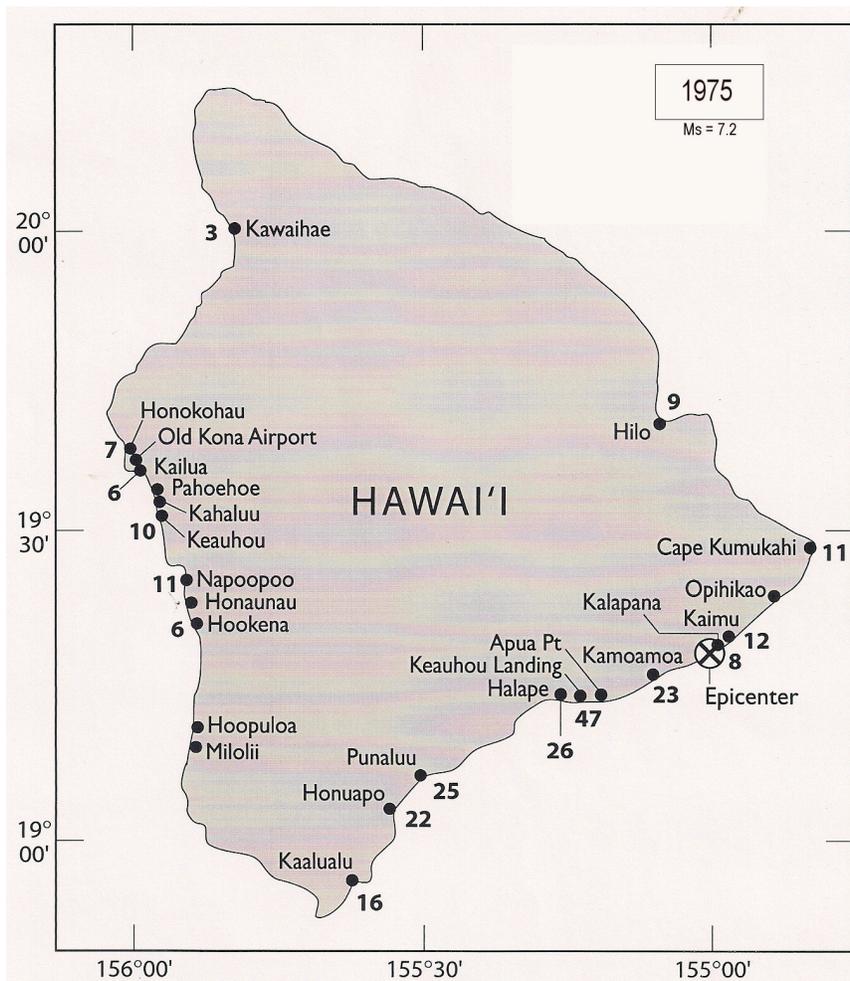
Figure 1. Earthquake epicenter, magnitude, and run-up values in feet for the 1975 tsunami (Lander and Lockridge, 1989). Run-ups are generally maximum vertical measurements of a tsunami's wave height relative to mean sea level. Inundation is a measure of a tsunami's maximum horizontal inland penetration.

Data for all of the reported significant locally generated tsunamis in the Hawaiian Islands during the 20th century are shown in Figures 1 and 2. A significant tsunami is considered here to be a tsunami with a runup of three or more feet. Runup is a measure of the tsunami's maximum vertical wave height on land relative to mean sea level. Inundation is a measure of the tsunami's maximum horizontal inland penetration. Also shown are data for the largest known and best documented local tsunami of the 19th century in Figure 3. No significant locally generated tsunamis have occurred in the Hawaiian Islands thus far in the 21st century and there are no reports of any local tsunamis having significant runups on any island other than the Big Island.

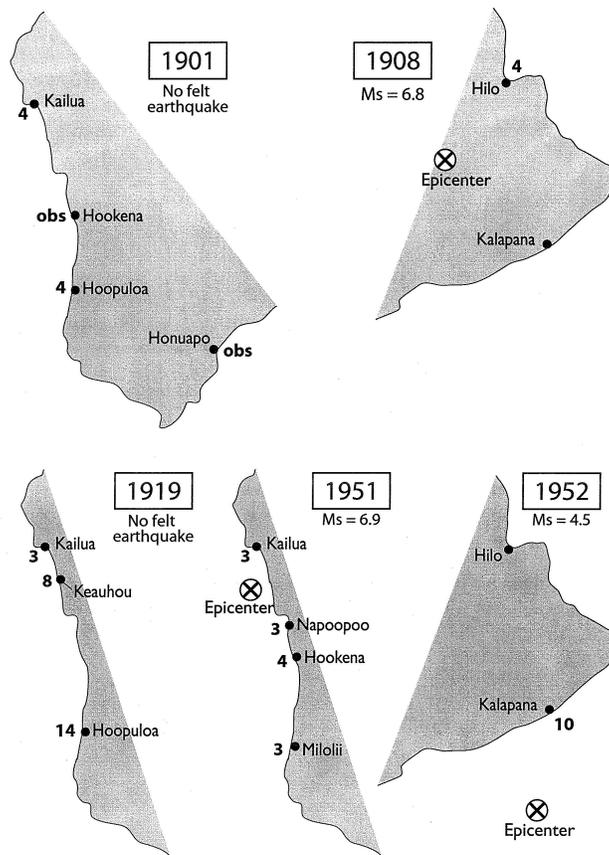
Figure 2. Earthquake epicenters, magnitudes, and run-up values in feet for other significant local tsunamis in the 20th century (Lander and Lockridge, 1989). In Hawaii newspaper articles discussing the 1901 and 1919 tsunamis, there were no reports of any felt earthquakes that might be associated with these tsunamis. There were also no reports of any instrumentally recorded earthquakes by the Hawaiian Volcano Observatory, which was in operation at the time of the 1919 tsunami. The 1901 tsunami was reported to have moved progressively southward from Kailua and around to Honuapo.

Note that some tsunamis (Figure 2) have occurred as a result of relatively small or unfelt earthquakes. Also, another possible unfelt earthquake generating a tsunami is one that may have occurred in 1869 with a run-up of about 27 feet between Pohoiki and Opihikao and inundation of about 800 feet (Cox and Morgan, 1977; and personal communication). Of the 23 Big Island earthquakes in the 20th century (Klein et al. 2001) with magnitudes of 6.0 or greater plus the 15 October 2006 earthquake near Kiholo, only the three shown in Figures 1 and 2 generated significant tsunamis. All of the foregoing data indicates that earthquake magnitudes are not reliable indicators of tsunamigenic potential. A better indicator would be actual evidence of a tsunami washing inland soon after the recording of a nearby earthquake.

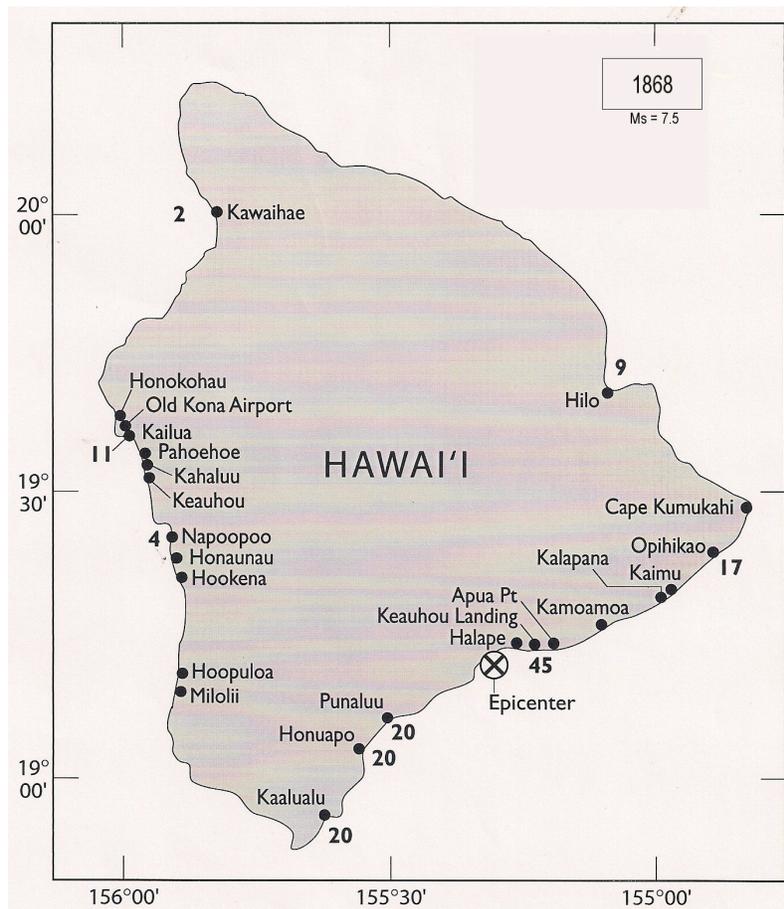
Figure 3. Earthquake epicenter, magnitude, and run-up values in feet for the 1868 tsunami (Lander and Lockridge, 1989). In addition, there are reports of the tsunami being observed at other Big Island locations. A value of 7 feet indicated for Apua may not be consistent with reports that all of the houses in the area were washed away. It should be noted that the waves could have been much larger as they swept across this extensive low-lying point of land. There may have been no topographic features in the area capable of providing reliable evidence of higher run-ups.

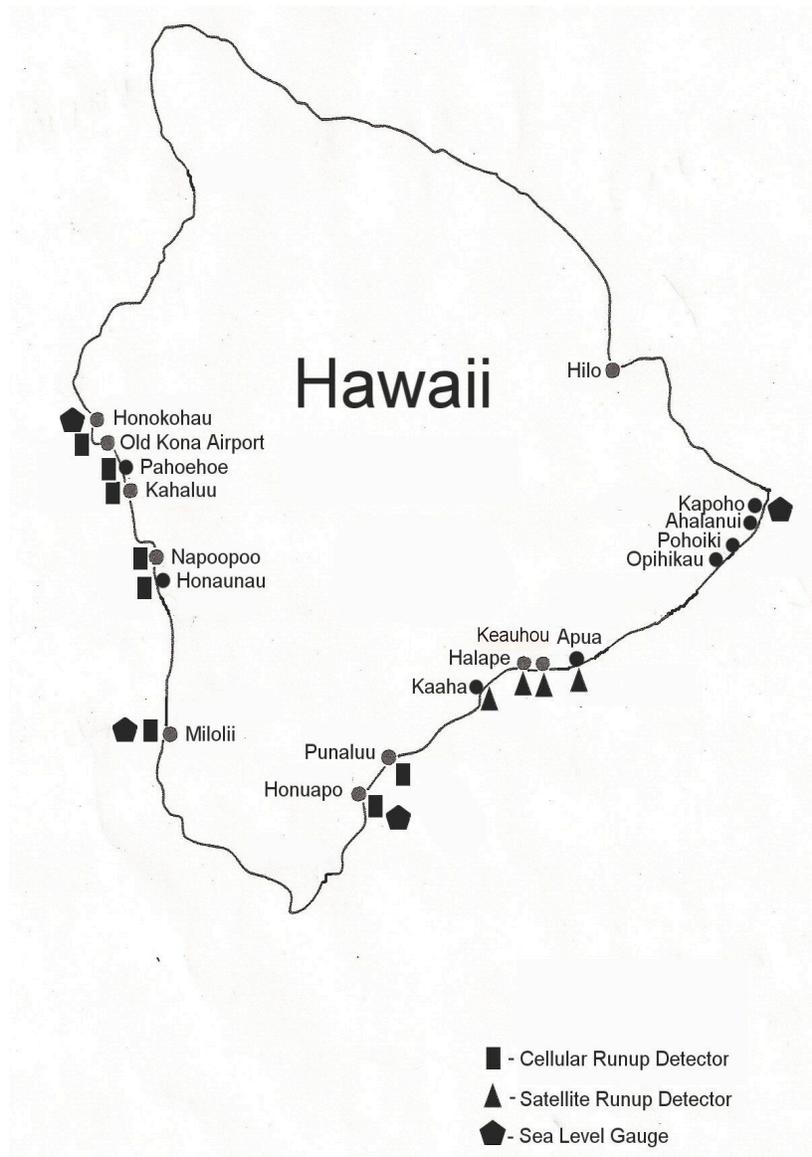
Figure 4. Site locations for Cellular Run-up Detectors (CRD's), Satellite Run-up Detectors (SRD's), and nearby Pacific Tsunami Warning Center sea level gauges.

Napoopoo, Kahaluu, Pahoeohoe Park, and the old Kona airport (Figure 4; Walker and Cessaro, 2002). Although these instruments complement the Pacific Tsunami Warning Center's (PTWC) sea level gauges at Kapoho, Honuapo, Milolii, and Honokohau, neither CRD's nor sea level gauges exist in the highly seismically active region of the Big Island extending from Punaluu to PTWC's sea level gauge at Kapoho. Much of this region is within the boundaries of Hawaii Volcanoes National Park (HAVO) with no roads, power, or civil defense siren poles. The largest locally generated tsunamis in Hawaii's history occurred in this region (Figures 1 and 3). Therefore tsunami detection instruments in these areas could provide for earlier, life saving warnings for heavily used parks to the north (Pohoiki and Ahalanui) and south (Punaluu and Honuapo). Also, much earlier warnings for the Hilo area and the Kona coast would be possible.

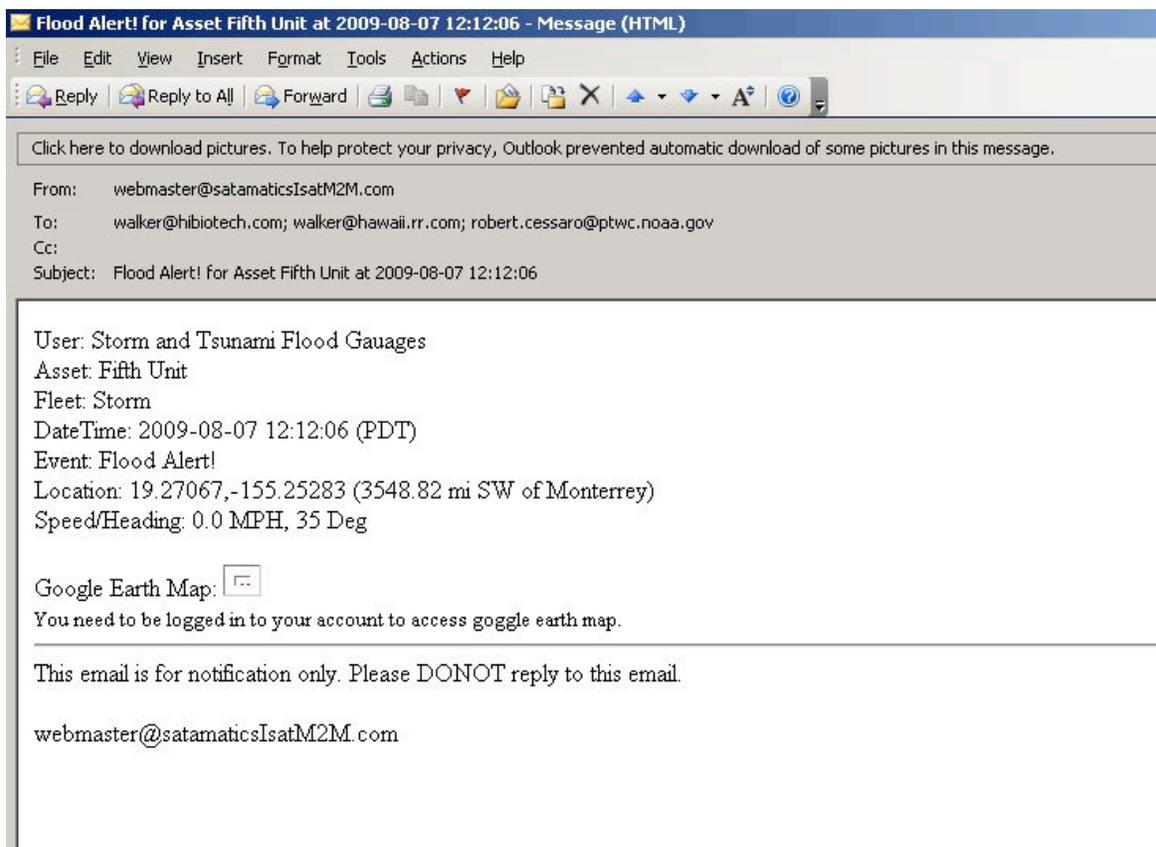
Figure 6. An example of a flood alert sent to authorized subscribers of the satellite service. This alert is for a flood test at Halape on 7 August 2009.

The sensor for the “campground siren system” installed at Halape is only a couple of feet below the elevation of most of the shoreline campsites, so it may, in most instances, provide for warnings of little value. Were the campsites further inland, at higher elevations, and not so widely distributed along the beach, such a system could be more effective. At Apua, Keauhou, and Kaaha there were no locations for which the existing “campground siren system” could serve any useful purpose. It will be important to monitor the survivability of the “campground siren system” and the four SRD systems in terms of heat, rain, insects, rodents, and humans. A unit on Oahu in a cooler, wetter environment with potentially less insect, rodent, or human interaction has thus far (through August 2009) operated without any problems or required battery changes for 10 months, giving daily position reports (Figure 5) and numerous flood alert test messages (Figure 6) during this time period.

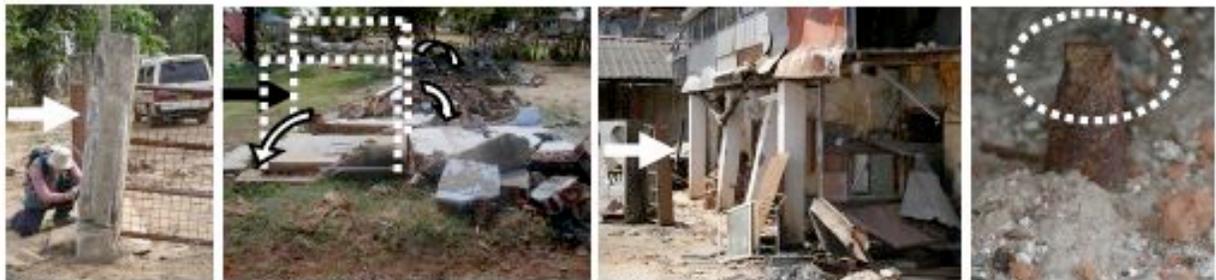
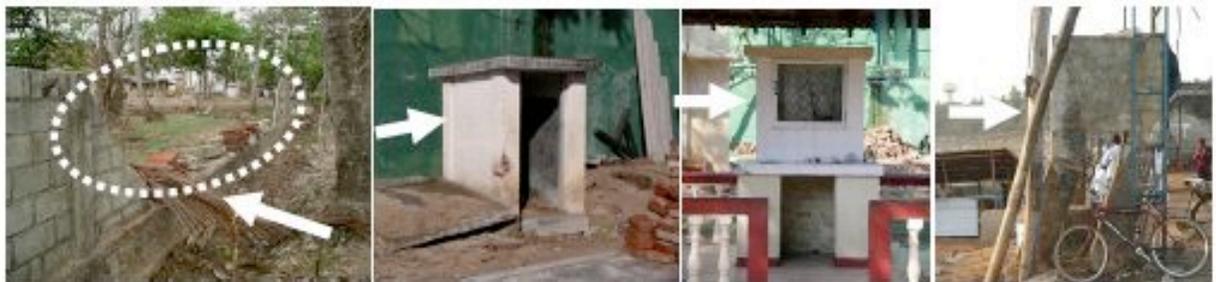
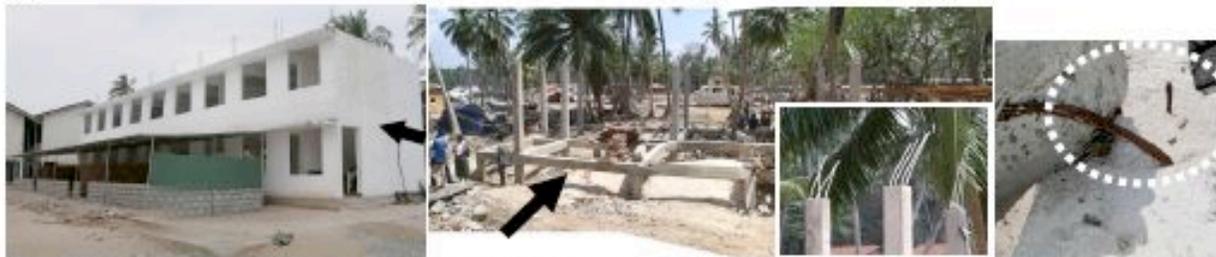
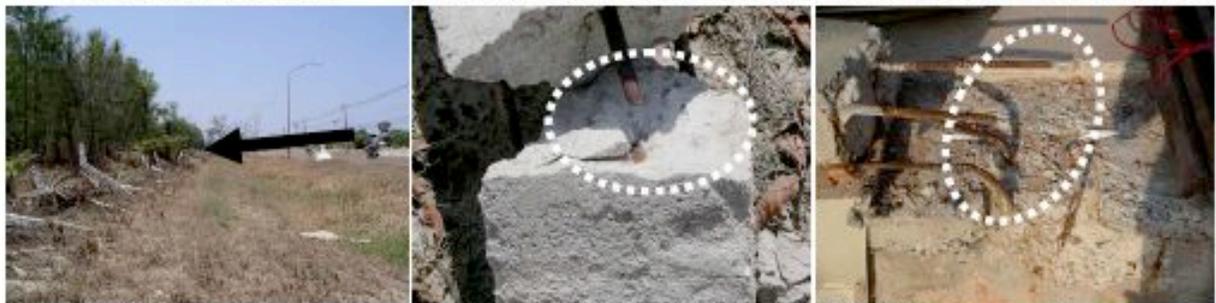
(1) S01: RC columns (2) S08: Brick outhouse (3) S16: Cantilever RC columns with rebar fracture

(4) S19: CB fence wall w/ RC column (5) S25: Brick outhouse (6) S26: Mausoleum (7) S32: Elevated water tank

(8) S53: 2-story RC school (9) S57: RC columns under construction (rebars bent and some columns failed)

(10) T09: RC fence columns of Navy Base (rebar fractured) (11) T15: RC columns under construction

Photo 1 Typical damage to investigated structures ("S01" etc: ID Nos. in Table 1, "→": tsunami flow direction)

Table 1 summarizes the investigated structures and photo 1 shows their typical damage patterns. Note that the structures categorized in (d) through (f) described above were generally found in the affected areas in Sri Lanka, and their data were collected to identify the criteria between damaged and survived structures even if they had minor or no damage. Detailed damage descriptions of surveyed structures and their structural information can be found in the related report (Nakano 2005).

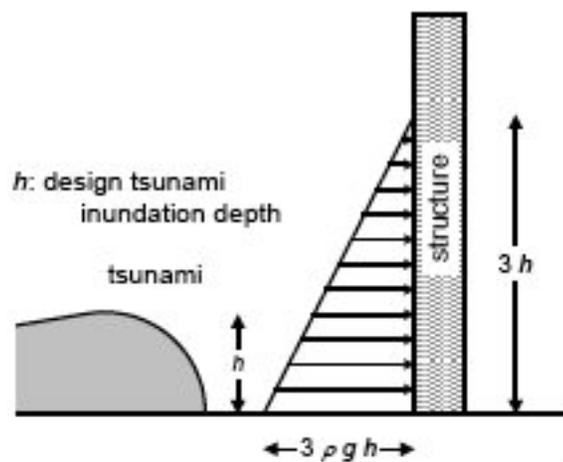
Figure 2 Design pressure tsunami distribution (JCO 2005)

Figure 2 illustrates the background concept employed in Eq. (4.1). The design tsunami pressure distribution acting along the structure's height is assumed a triangular shape with the height reaching 3 times of the design tsunami inundation depth h (i.e., the pressure at the bottom is assumed 3 times of the hydrostatic pressure), which is based on the laboratory tests of 2-dimensional scaled model (Asakura et al., 2000). To examine whether or not the coefficient 3 in Eq. (4.1) is appropriate to evaluate the tsunami load, Eq. (4.2) is introduced in the manner analogous to Eq. (4.1). If the coefficient a successfully categorizes damaged and survived structures at its value of 3, one can say that Eq. (4.1) with a equal to 3 is a rational design formula to compute the tsunami load effect. In calculating the coefficient a , two typical cases of inundation depth and structure's height, which can be found in the guidelines (JCO 2005), are taken into consideration as shown in Figure 3 since they are the basic patterns of tsunami attack to existing structures in the surveyed areas.

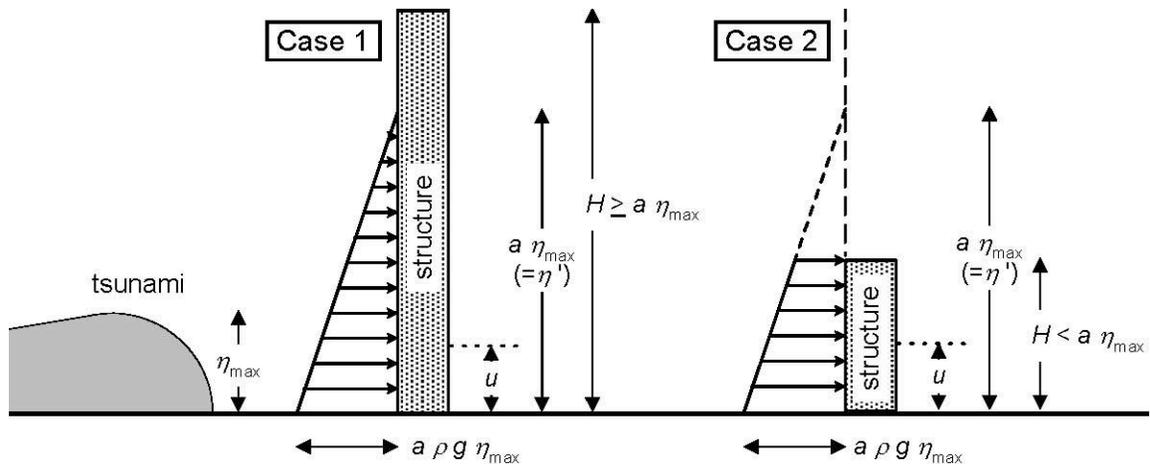
Figure 3 Tsunami inundation depth η_{\max} , building height H , and tsunami pressure distribution p_x (Nakano 2007)

1. Compute the lateral resistance of investigated structures considering their failure mode as shown earlier in Section 3.
2. Then compute shear force or bending moment acting at the failure point u (defined as the distance between the failure point and the ground surface) assuming the tsunami pressure distribution as defined in Eq. (4.2). Setting the force or moment at the height u equal to the lateral resistance obtained in step 1. above, evaluate the equivalent water depth η' corresponding to the resistance. Note that the tsunami pressure above structures is neglected and the depth η' is evaluated assuming the trapezoidal instead of triangular pressure distribution in computing the force or moment as shown in case 2 of Figure 3.

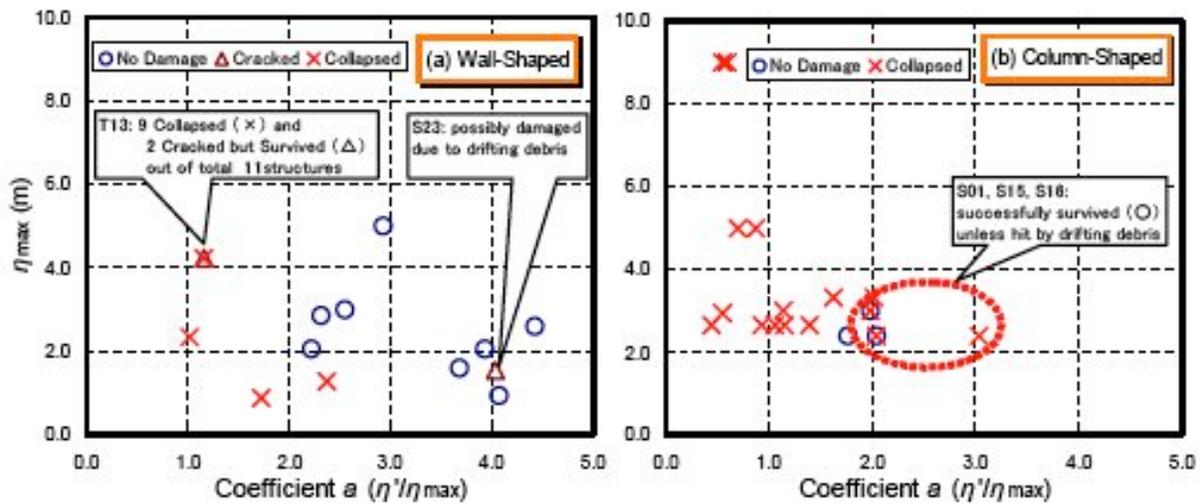
Figure 4 Computed Coefficient a vs. observed tsunami inundation depth η_{max} (Numerals in the figure denote ID Nos. in Table 1)

Table 1 shows the investigated tsunami inundation depth η_{\max} and the computed coefficient a . Their relationship is shown in Figure 4(a) for wall-shaped structures such as fence walls and in Figure 4(b) for column-shaped structures such as cantilever RC columns, respectively, where the structure type is determined based on the shape of member on which the tsunami attacks. When the structures with identical structural properties have different failure patterns due to the effects of drifting debris or some other reasons, two marks corresponding to different failure patterns are plotted at the same point of the figure.

Figure 4(a) shows that structures with the value of a greater than 2.5 have no major damage except for the case S23 that may have been damaged due to drifting debris, and the value of 3 for the coefficient a proposed in the guidelines can be considered rational to avoid serious damage due to tsunami attack. It should be noted, however, that the structure (S23) having the coefficient a greater than 4 suffers wall cracking, and the coefficient of 3 may not be conservative if the load amplification due to drifting debris is taken into account, and countermeasures to protect structures from damage due to drifting debris need to be taken.

Figure 4(b) shows that the coefficient a for column-shaped structures to discriminate between damaged and survived may lie at around 2 when the effects of drifting debris are neglected, which is slightly lower than that for wall-shaped structures. This result implies that column-shaped structures have advantage in tsunami resisting performance over wall-shaped structures on condition that both structures have enough seismic capacity to survive the ground shaking prior to the tsunami attack. It should also be noted, however, that the column-shaped structures can not be left undamaged at the coefficient a in the range of 2 to 3 as shown for the cases of S01, S15, and S16, and countermeasures against drifting debris need to be taken to protect structures as is the case of wall-shaped structures previously described

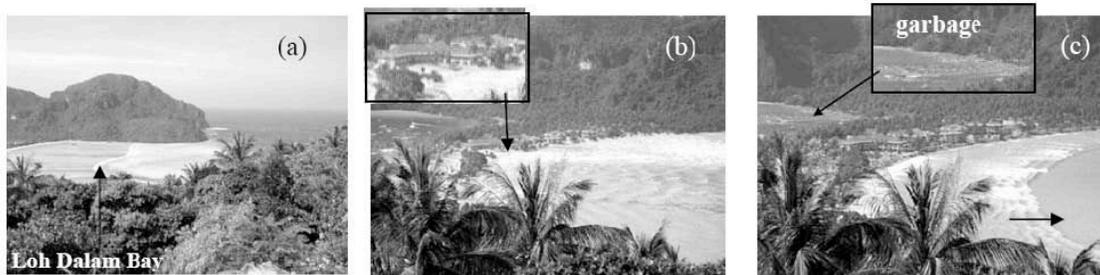
Fig. 4 (a) Tsunami approaching from the north side of tombolo (b) tsunami impacting the north side of tombolo and causing overflow, (c) wave retreating northward with lots of debris floating on the south side of the tombolo

Both north and south sides of the tombolo suffered extensive damage. Internet photos (Fig. 4) indicate that the tsunami came from the north side of the tombolo (Loh Dalam Bay, Figs. 4a & 5a). The run-up height reached the second floor of the hotel there (Fig. 4b) and overflowed the tombolo towards Ton Sai Bay (Figs. 4c & 5a). It is believed that the higher run-up was the result of Loh Dalam bay's deeper bathymetry and coastal configuration. Figure 4c shows the tsunami wave retreating northward to the sea. The enlarged small photo at Fig. 4c shows debris floating in Ton Sai Bay. Eyewitnesses stated that tsunami waves approached the tombolo from both north and south directions. By measuring the scar on top of coconut trees there, the maximum tsunami run-up height was determined to range from 14 to 16 meters (Fig. 5b). Coral boulders with diameters ranging from 1-3 m were uplifted by the tsunami on the north side of the tombolo (Fig. 5c). Figure 5d shows a toppled 2-meter high statue on a pedestal. The steel bars connecting the statue and the stand were all bent in a SE direction, indicating that the stronger tsunami waves came from the north side of the tombolo.

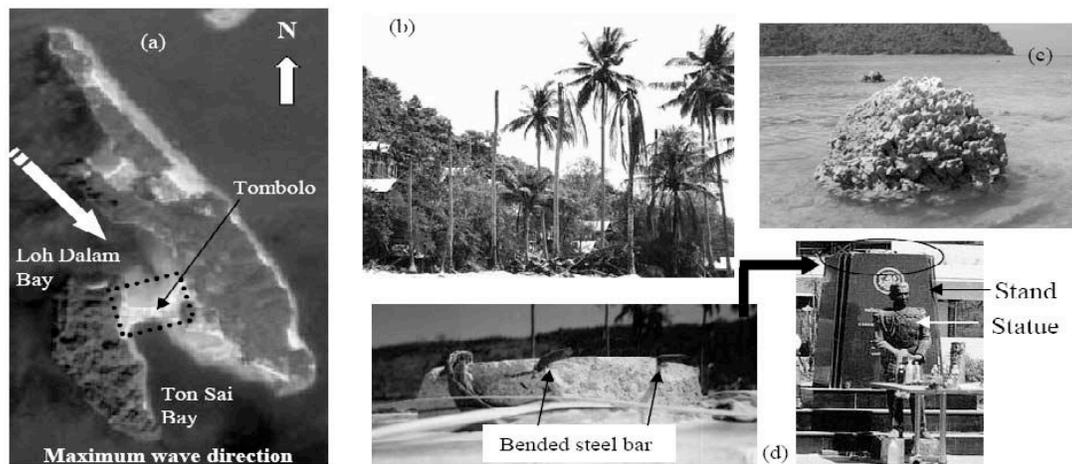
Fig. 5. Tsunami damage on north and south side of tombolo.

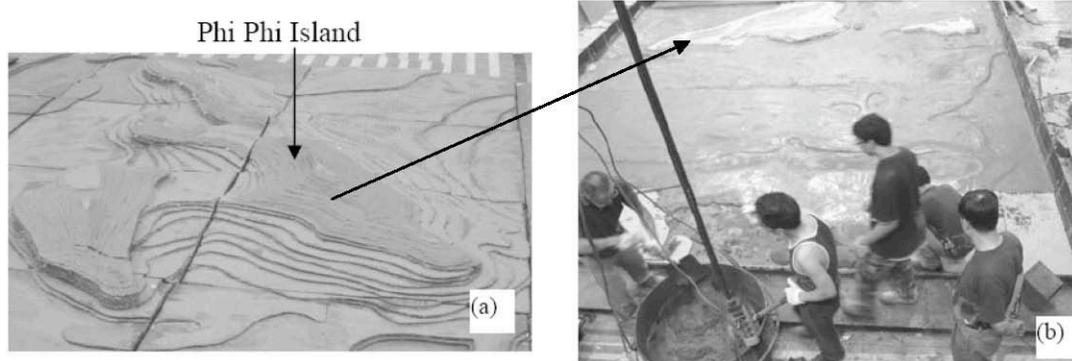
Fig. 6 (a) Model of Phi Phi Island, (b) Submerged portion of the model being covered with a layer of concrete (Model of the island fixed within a 6m×6m×0.3m steel tank).

The physical model of Phi-Phi Island (Fig. 6a) was constructed from corrugated paperboards, each with a paper thickness of 0.6 mm. For a physical hydraulic model, it is normally impossible to have a 1-to-1 vertical and horizontal scale. Some kind of distortion of the vertical scale seems acceptable to avoid the effects of capillary rise and surface tension of the water. Previous experimental studies normally used a scale ratio h/v (horizontal scale/ vertical scale) ≤ 4 , so that the distortion due to the scale effect can be negated (Whalin and Chatham, 1976). However, due to the limited space of the laboratory, an h/v ratio of 5 was used by this study with the horizontal scale being 1:2,500 and the vertical scale being 1:500 for the submerged portion of the model but remains at 1:2,500 scale for the portion above water level. The island was scaled down to about 3m in length and 1.5m in width. The whole model was fixed in a 6m×6m×0.3m (length×width×height) lower steel tank (Fig. 6b).

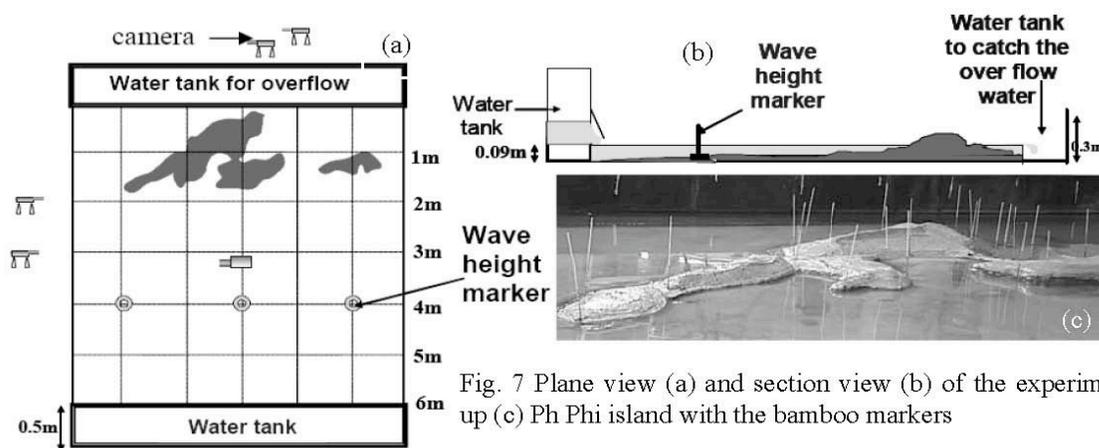
Fig. 7 Plane view (a) and section view (b) of the experimental set up (c) Ph Phi island with the bamboo markers

The physical model, including the island and the submerged portion, were covered by a layer of concrete. After the cement paste is hardened, Water was added to the tank to an approximate level of 90 mm. A separate water storage tank of 6m×0.5m×0.6m (called tsunami tank hereafter) was constructed to serve as the source of tsunami waves and was placed at the far end of the model (Fig.7). A gate was installed at the lower part of the tsunami tank for the sudden release of the water and the generation of simulated waves. The water tank was built on movable rollers outside the model so that the angle of tsunami direction could be adjusted. To prevent wave reflections from the two sides and the opposite wall of the model, a soft 60 mm thick water-absorbent material was mounted on all three sides with an overflow edge at the far end to prevent reflections from behind Phi-Phi Island replica. Wave height markers (Fig. 7a) and bamboo markers (Fig. 7c) were installed to measure the height of the waves and the run-up on the island. Additionally, five video cameras were installed at different locations to record the formation of edge waves and the maximum run-up in the model. Simulated waves were generated having heights varying form 30mm, 40mm and 50mm. Some of the results of our experimental observations are given in the next section.

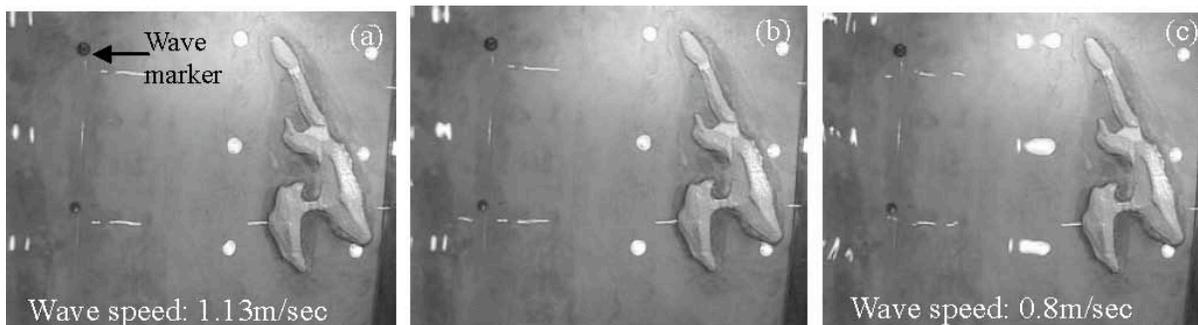
Fig. 8 Wave propagation and interaction with coastal morphology in the generation of edge waves

Figure 8 shows a sequence of photographs taken from the top of the model, illustrating the wave propagation toward the island. For this particular experiment, the water depth in the tsunami tank was 40 mm with an orientation of $N0.0^\circ$. Once the gate was opened, a line of water was generated and propagated toward the island. Initially observed was the formation of a zone of water level depression (or water draw back) ahead of the first crest, which agreed with observations in Thailand that the sea retreated prior to arrival of the first tsunami wave (see elongation of light reflection before the wave in Fig. 8). The same phenomenon has been observed with many tsunamis in the past – specifically that a wave of higher crest is followed by a number smaller undulations. A mathematical wave called soliton has a similar waveform, similar to a tsunami. Another observation was the reduction of wave speed due to changes in bathymetry. The waves refracted with changes of water depth and coastal configuration. At the tombolo the water first retreated, then rose drastically. At wave marker (2 m away from the water tank), the average wave height was about 14 mm above mean water level, while the wave run up height at the tombolo was 21 mm at the south side and 30mm at the north side. The wavelength was about 0.45 m. The wave speed, at 1 m away from the tsunami tank, was 1.13 m/sec and it decreased to 0.73 m/sec at 2.5m from the tsunami tank. As illustrated by the modeling study and presented in detail in the next section, depth of water and coastal morphology are critical factors in the resulting tsunami run up.

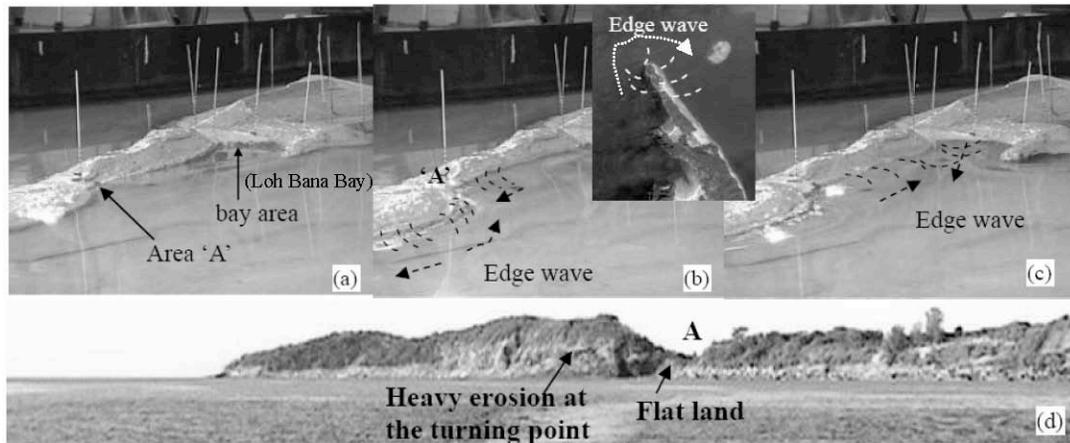
Fig. 9 Illustration showing tsunami wave attack on northern area of the model of Phi-Phi Island

photo of Fig. 9b) moving downward along the backside of the island. On the right side of the flat land 'A', a reflected wave (edge wave) was observed traveling along the coastline and moving towards to the southern bay (Fig. 9c). However, since there is no outlet for the water there, the surge reflected back and interacted with the incoming edge waves to form a highly non-uniform and localized run-up height along the northern coastline. This also explains what we actually observed along the northern coastline of Phi-Phi Island. Therefore, the experiments provided useful insight of what happened in this area when the tsunami of December 26, 2004 struck.

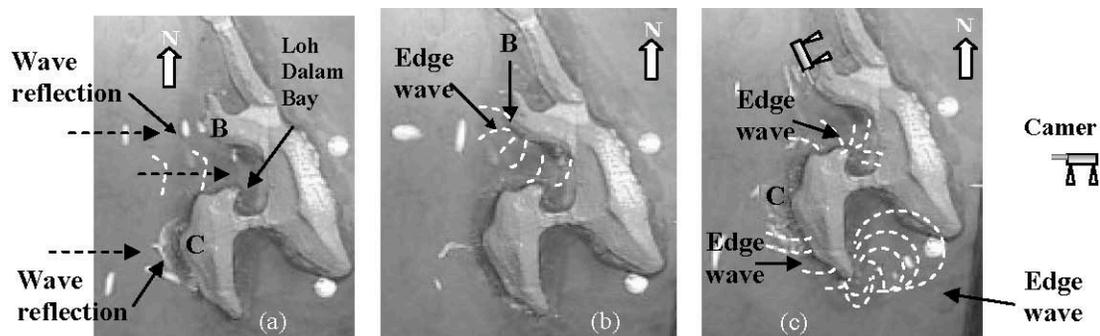
Fig. 10 The plane view of the edge waves moving into the bay area of the north side of tombolo.

It was observed that when the wave propagated towards Loh Dakam Bay, part of the wave reflected at area B and C (Fig. 10a) while part of the wave moved directly into the bay area. It was observed that at area B, the edge wave moved along the coastline propagating downward to the bay area (Fig. 11b). At the same time the reflected wave (or edge wave) moved along the coastline of area C also propagated toward the bay area (Fig. 11c). As a result, three sources of water flow into the bay area caused the 30 mm run-up height at the north side of the tombolo.

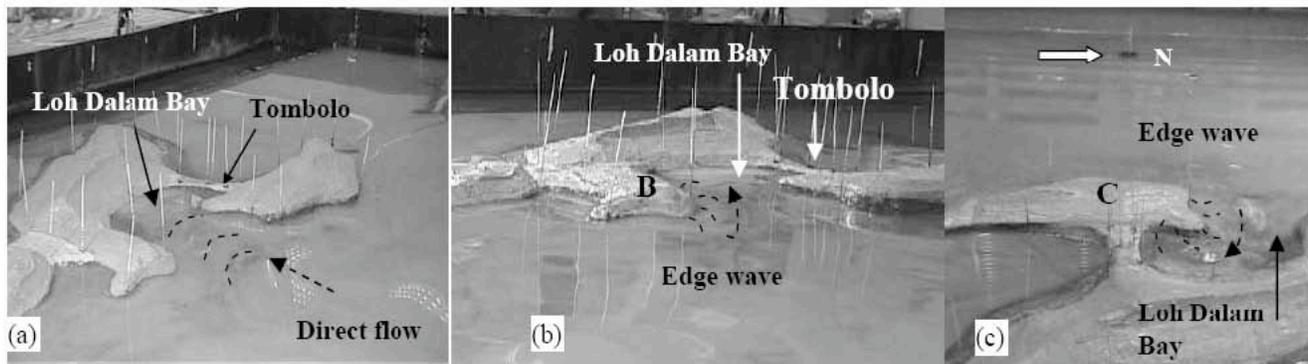
Fig. 11 Photos showing the sources of water from the northern side of the tombolo (Loh Dalam Bay)

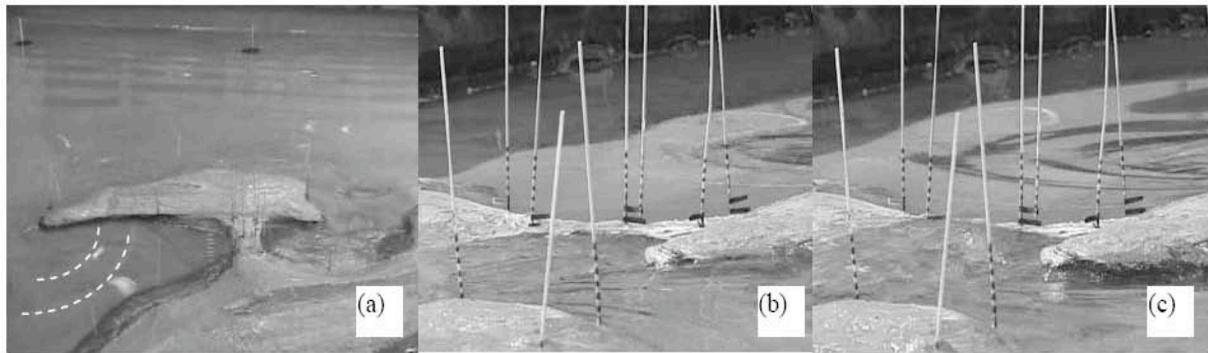
Fig. 12 (a) Edge wave propagation along the coastline, (b) and (c) show the flooding and overflow at the north side of the tombolo while the edge wave propagation from the south side was still going on.

There is no direct flow source for the south side of the tombolo, since the south bay is sheltered from direct tsunami impact. However, the experiments also show that edge waves were formed and traveled around the left headland. More specifically, when the simulated tsunami wave propagated towards to southern end of the island, it was observed that edge waves were formed that continued to move along the coastline towards to the tombolo (Fig. 11c). Three more photos of the tombolo area taken from different angles are shown in Fig. 13. Figure 13a was taken from the eastern camera while Figs. 13b and 13c were taken form the northern camera. It was observed that edge wave turned around the southern tip of Phi-Phi Island (Fig. 13a) and propagated across to the bay towards the southern side of the other island, with wave fronts nearly parallel to the tombolo (Figs. 13b & c). As a result, the wave arrival time from the south side of tombolo is later than that from the north side. Figure 13c clearly shows that when the surges overflowed the tombolo from the north, the edge wave from the south side was still advancing toward the tombolo. The difference in arrival time on the two sides was about 2.5 sec. Because the source of water from the south was only from the edge wave, the run-up height was only 21 mm. The field observations were in full agreement with the conclusions derived form the hydraulic model experiments. As shown in Figs. 4b and 4c, when the tsunami approached from the north side of the tombolo, the sea on the south side was calm. The debris on the south side resulted by the overflow of water from the north side. That is, wave reached first the north side of the tombolo and the run-up was higher.

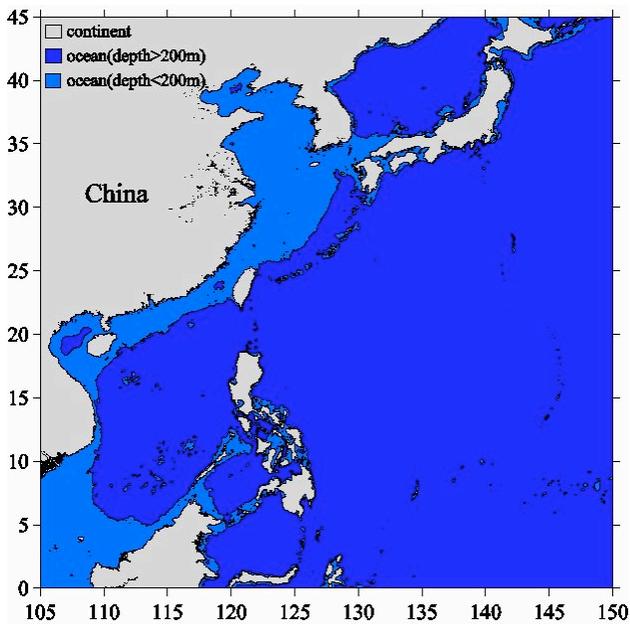
Fig. 3. Bathymetry of China coast (200m depth)

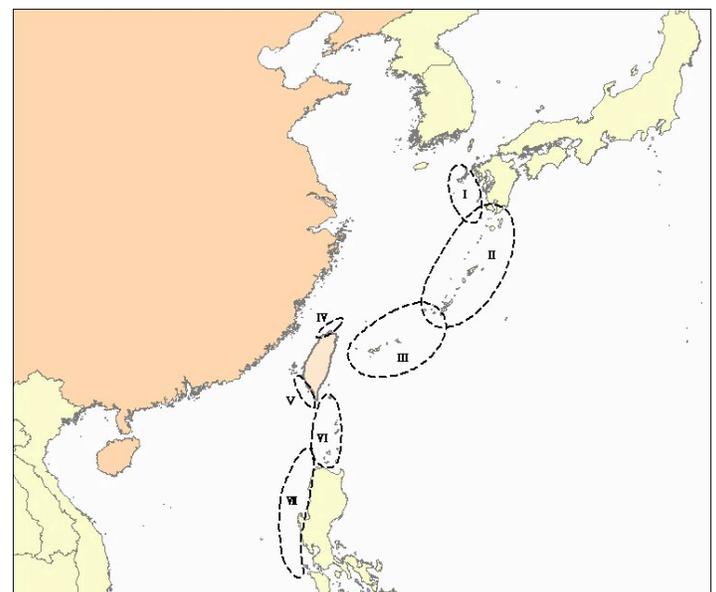
Fig. 4. Source regions of tsunamis that could potentially impact China's coasts.

source regions were reasonably delineated, as shown in Figure 4.

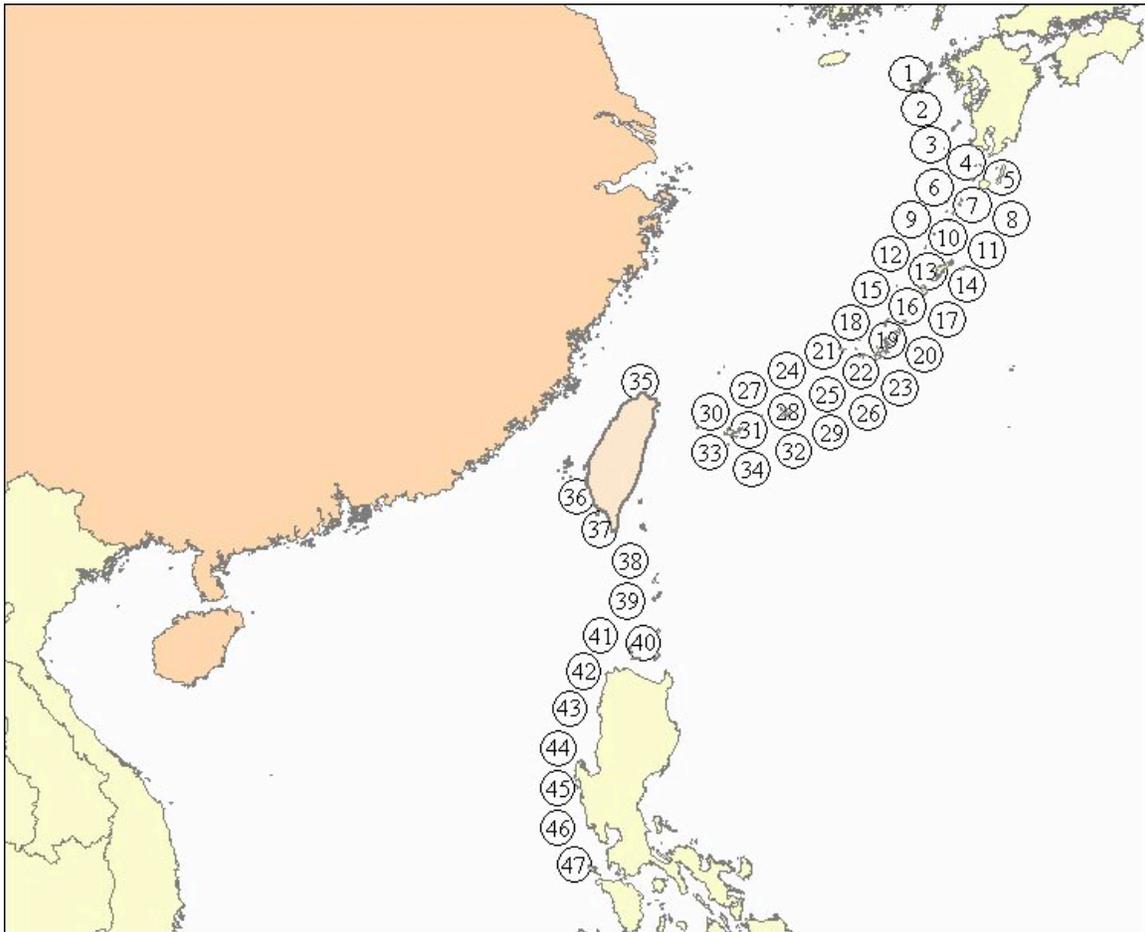
Fig. 5. Distribution of potential tsunami sources that can potentially impact China's coastlines.

For modeling purposes, 47 potential tsunami sources with 50km radius were selected, as shown in Figure 5 to apply initial water displacements. Each tsunami source was depicted as a cone-shaped area with maximum height of 5m, as shown in figure 6. It should be noted that the initial displacement field for each source in the numerical tsunami simulation was estimated on the basis of fault dislocation in elastic half-space. However, point sources were depicted due to the lack of fundamental information on active faults. Tsunami wave heights were normalized first, as not to result in erroneous assessment results that would unduly elevate the tsunami hazard along China's coasts.

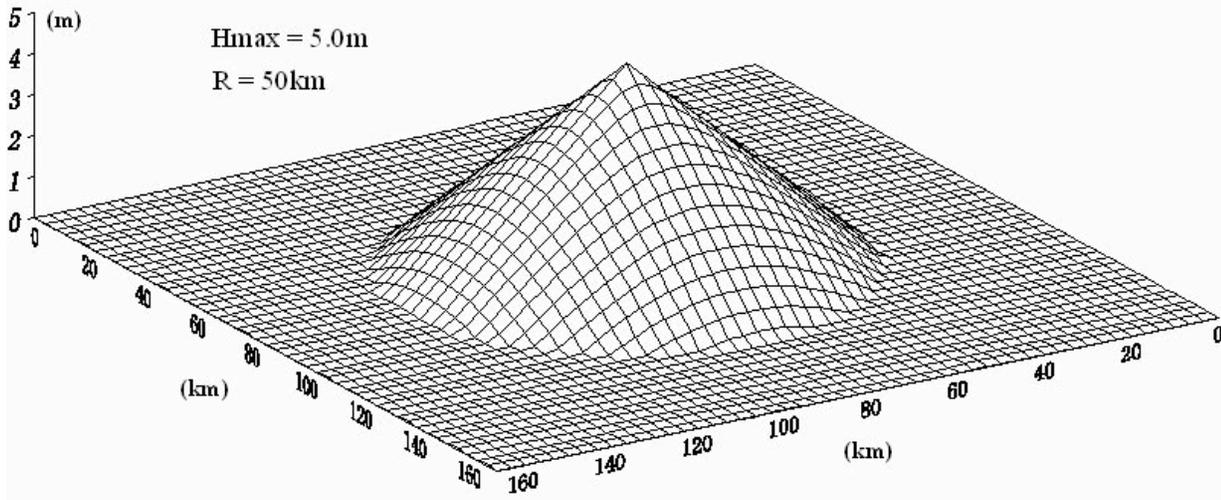
Fig. 6. The postulated shape of each potential tsunami source

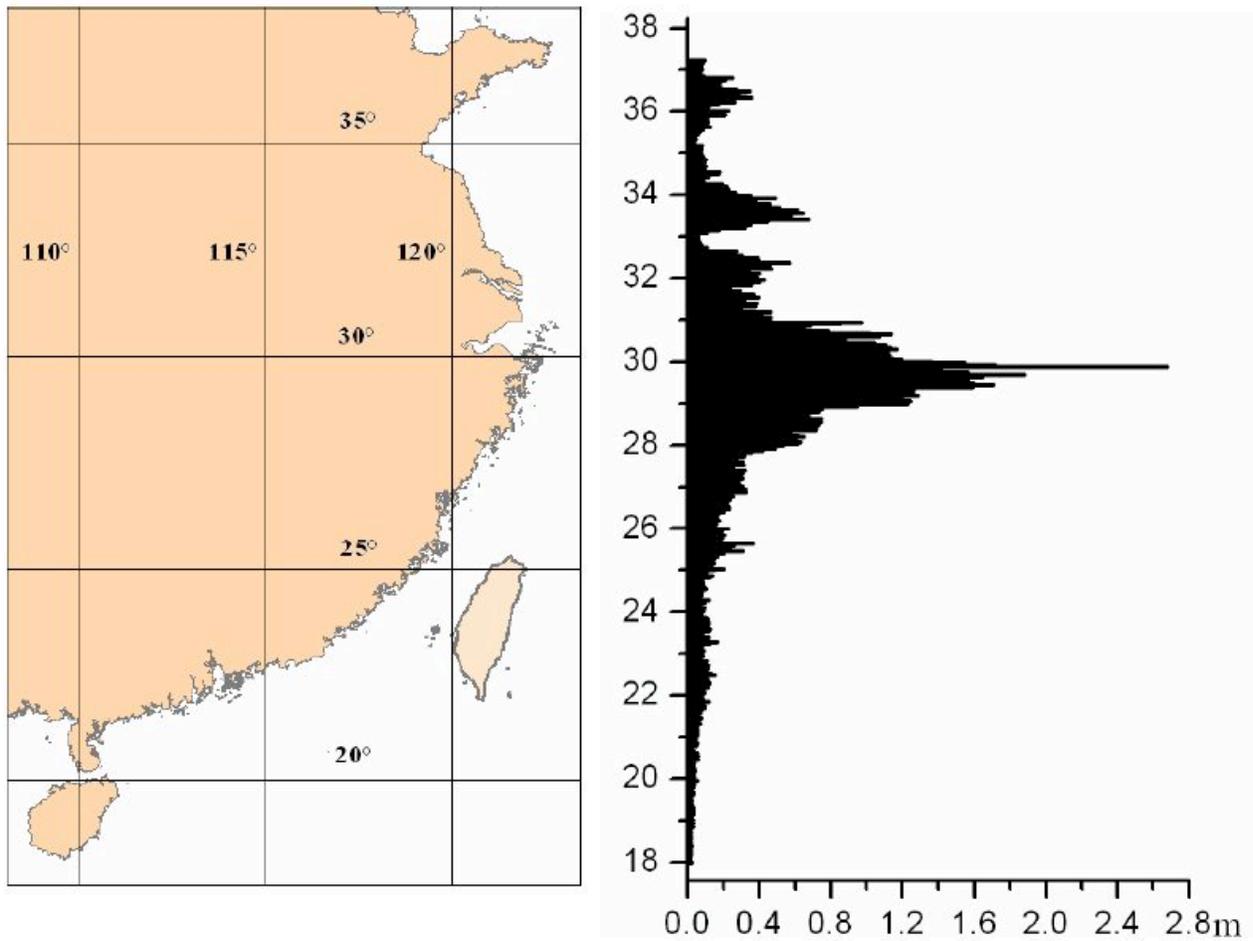
Fig. 7. Tsunami run-up heights along China coast from the No.18 tsunami source.

Figure 7 below shows the tsunami heights along China's coasts resulting from the mathematical simulation of waves originating from the No.18 tsunami source. A maximum height of 2.67m occurred near the area with latitude 30°N., indicating that this was the region of the highest tsunami risk. Perhaps the high run-up value results from the short distance to the No.18 tsunami source.

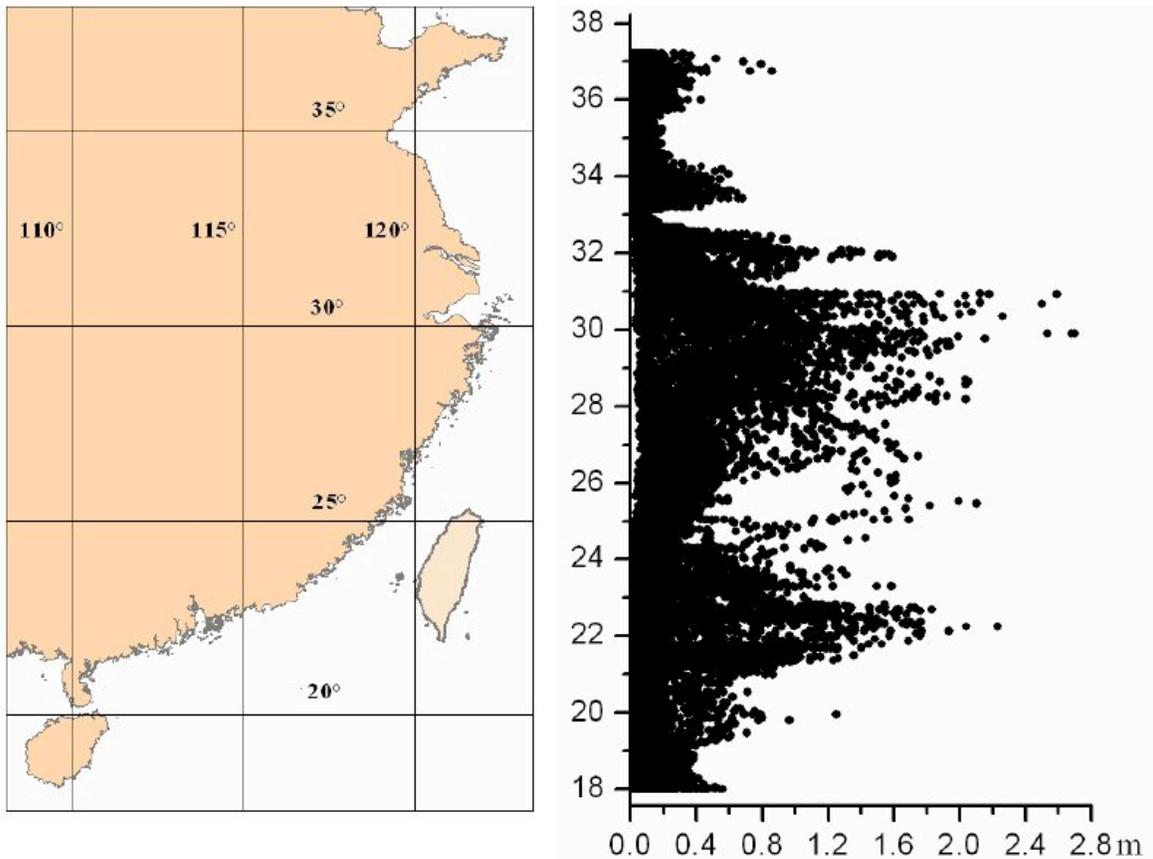
Fig. 8. Tsunami run-up heights along China's coast line from all 47 potential tsunami sources.

However, for a complete tsunami risk evaluation along China's coastlines, all the results from all potential sources must be comprehensively analyzed and integrated. Figure 8 summarizes the tsunami run-up heights from the mathematical modeling of all 47 potential sources.
