SCIENCE OF TSUNAMI HAZARDS

The International Journal of The Tsunami Society
Volume 29 Number 1 Published Electronically 2010

DESIGN LOAD EVALUATION FOR TSUNAMI SHELTERS BASED ON DAMAGE OBSERVATIONS AFTER INDIAN OCEAN TSUNAMI DISASTER DUE TO THE 2004 SUMATRA EARTHQUAKE 11

**DESIGN LOAD EVALUATION FOR TSUNAMI SHELTERS BASED ON DAMAGE
OBSERVATIONS AFTER INDIAN OCEAN TSUNAMI DISASTER DUE TO THE 2004
SUMATRA EARTHQUAKE**

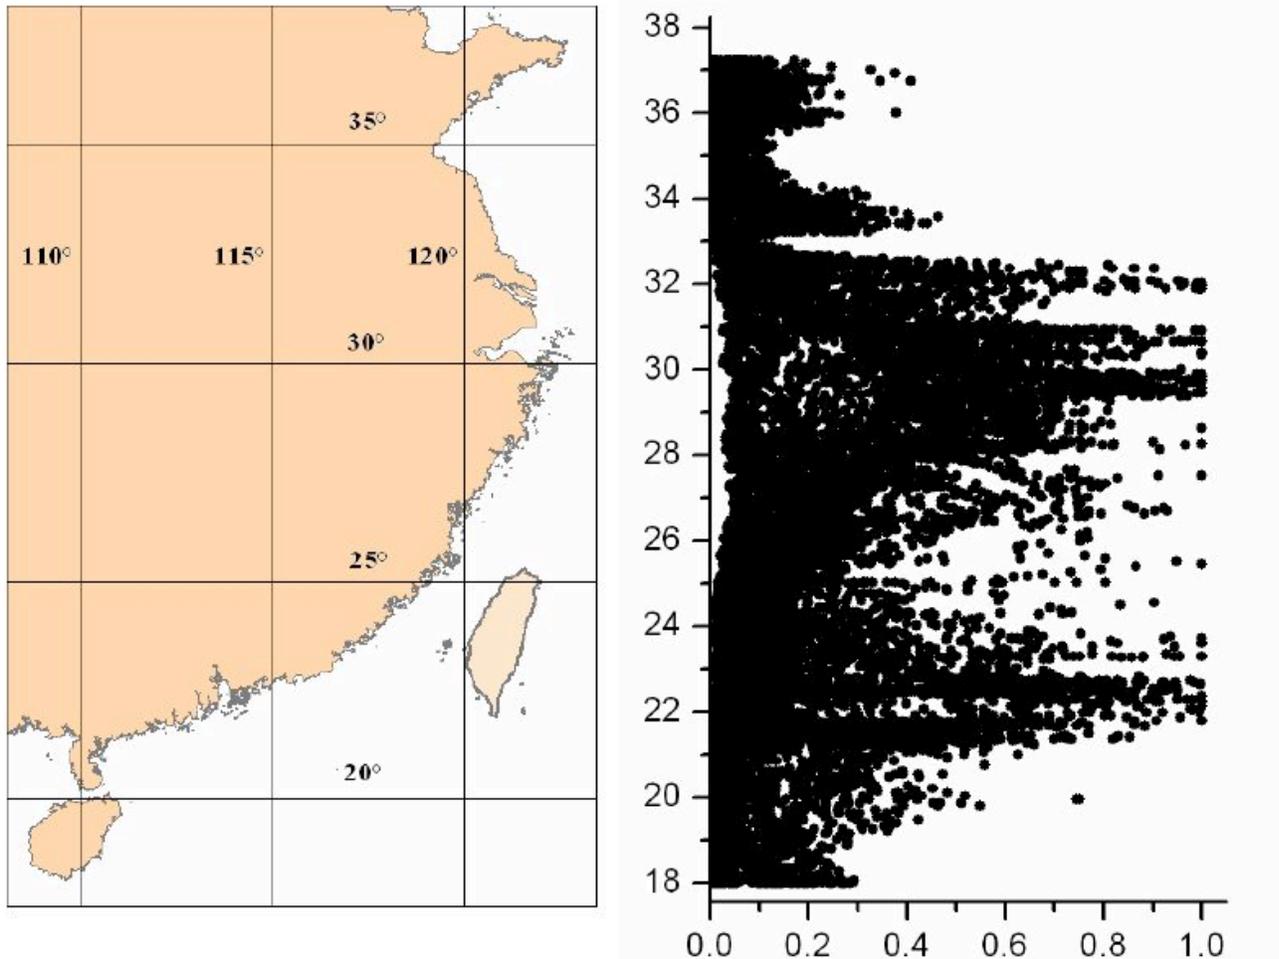
Figure 9. Values resulting from normalizing all tsunami run-up height.

(2) From the Yellow Sea to Hainan Island and in three areas near the deltas of the Yangtze, Qiantang and Pearl river, the potential tsunami hazard is higher than in other coastal areas. On the basis of the proximity of earthquake sources, coastal areas along the East China Sea are more vulnerable, while coastal areas along the South China Sea are less vulnerable. The lowest tsunami hazard vulnerability is assigned to coastal areas fronting the Yellow Sea.
